Dam Safety Inspection Report Sedgwick, Kansas

KDA DWR WSN: DHV-0052
PEC PROJECT NO. 237088-002-1223
June 2023

PREPARED BY
Professional Engineering Consultants, P.A.
400 S. Kansas Ave. Ste. 200
Topeka, KS 66603
785-233-8300

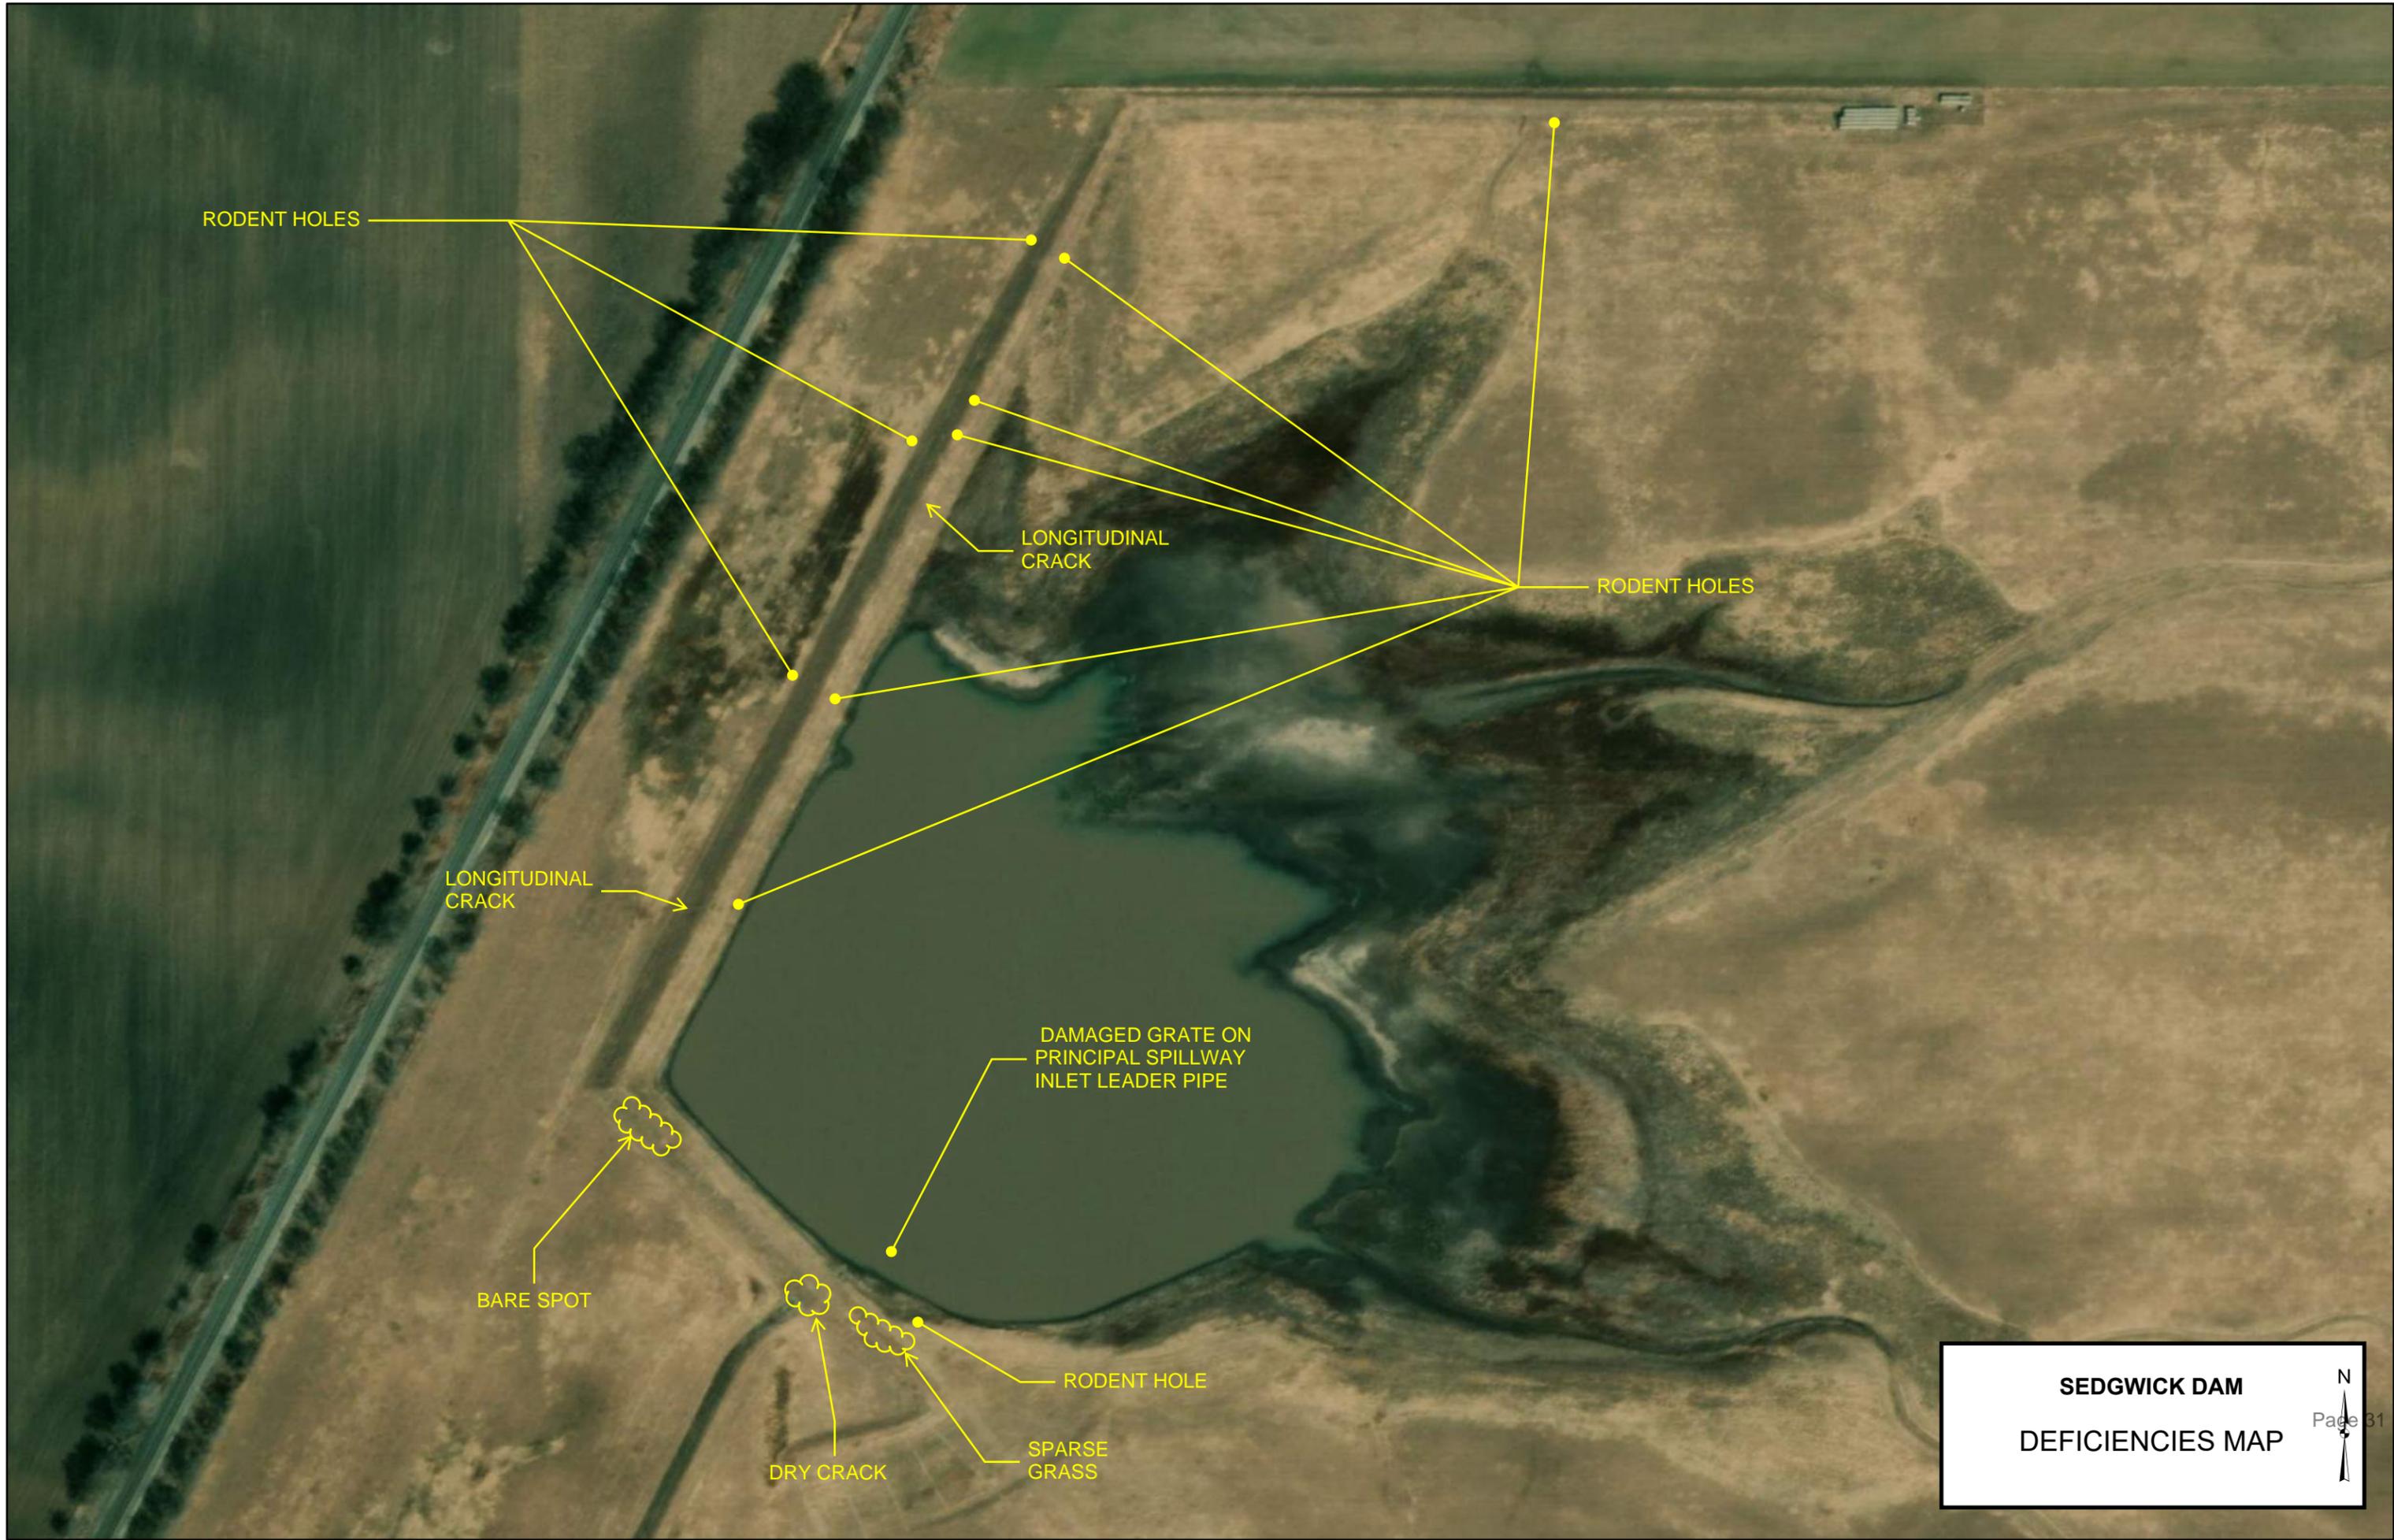
SEDGWICK DAM
DEFICIENCIES MAP

RODENT HOLES

LONGITUDINAL CRACK

DAMAGED GRATE ON PRINCIPAL SPILLWAY INLET LEADER PIPE

DRY CRACK

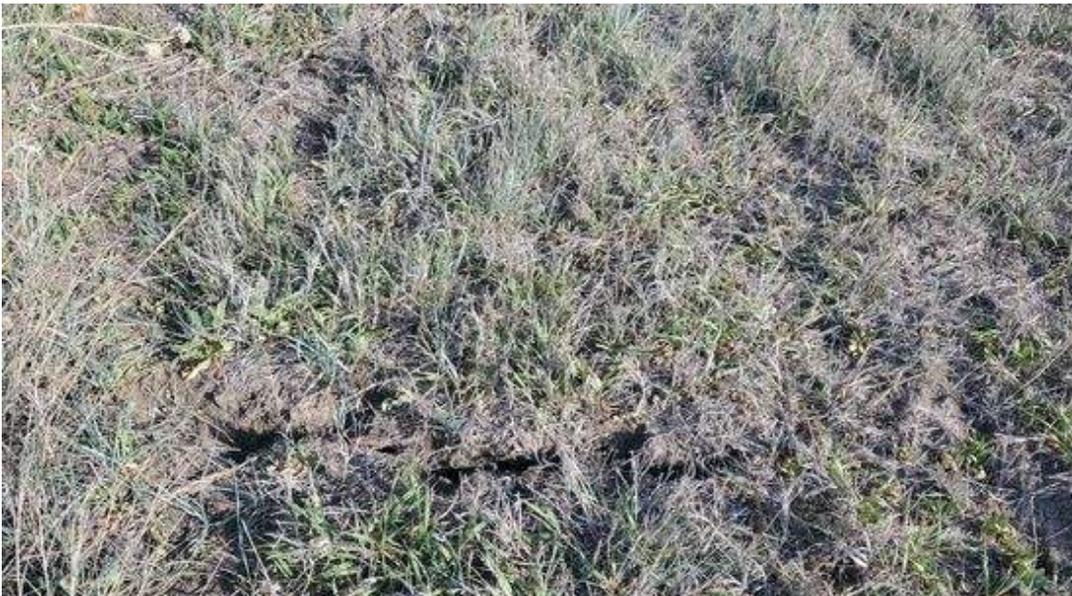
Photo Number: 8

Direction: N Short Description or Location: Downstream Slope
Detailed Description: DRY CRACKING ON DOWNSTREAM SLOPE BY THE PRIMARY OUTFALL.

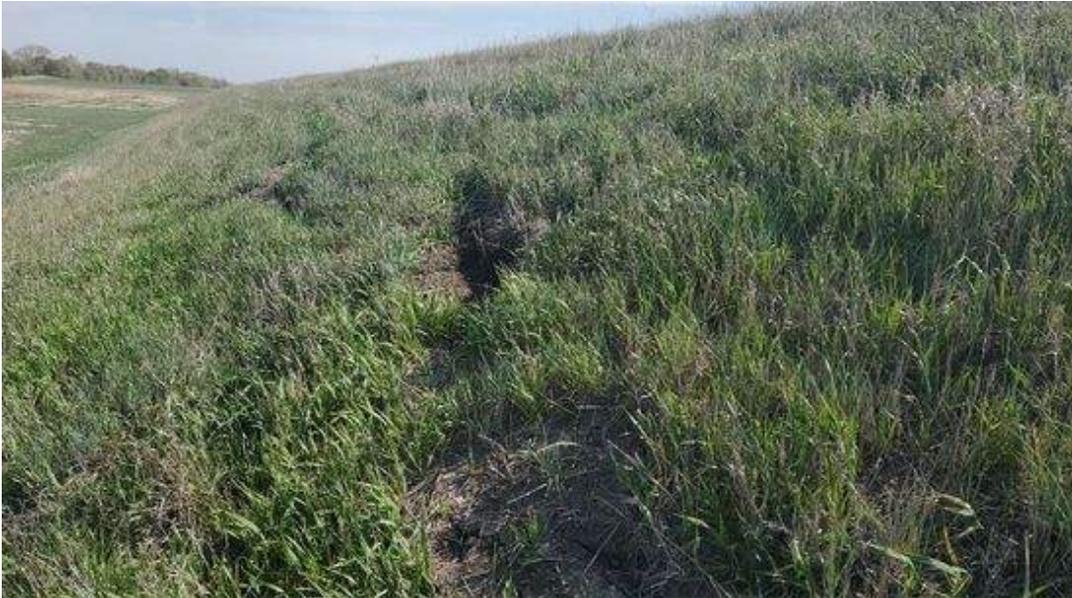
Photo Number: 11

- a) *Principal Spillway Pipe/Inlet* – Metal grate on the pipe leading to the drawdown inlet structure needs replaced.
- b) *Upstream Slope* – Alternate mowing patterns to prevent further longitudinal cracking of the slope, which can be seen in Photo 31.
- c) *Downstream Slope* – Alternate mowing patterns to prevent further longitudinal cracking of the slope, which can be seen in Photos 11 and 12.

Direction: NE Short Description or Location: Downstream Slope
Detailed Description: LONGITUDINAL CRACKS ON THE DOWNSTREAM SLOPE.

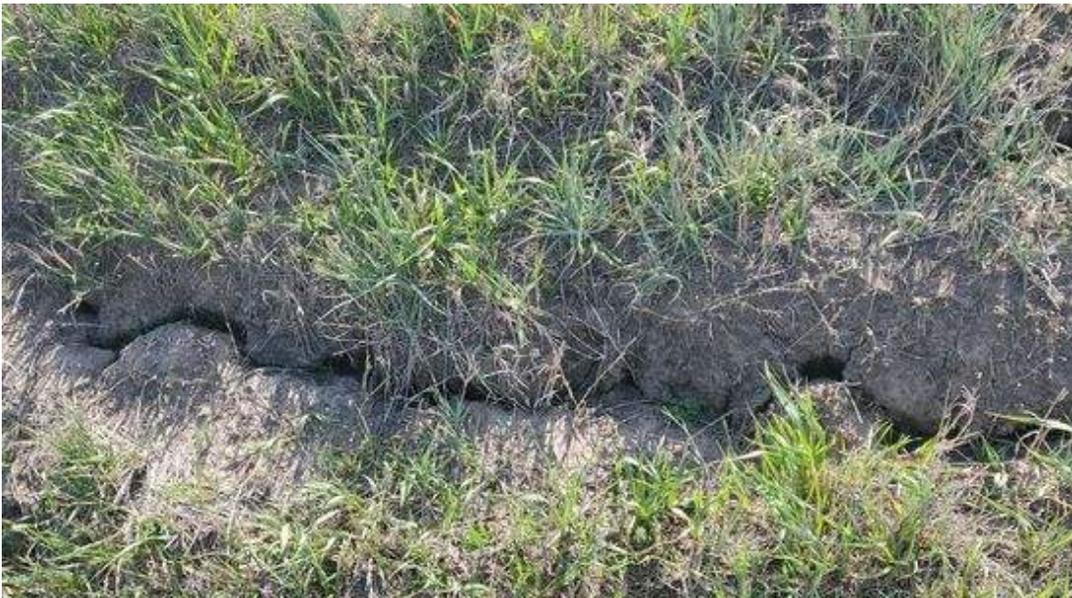
Photo Number: 12

Direction: E Short Description or Location: Downstream Slope
Detailed Description: LONGITUDINAL CRACKS ON THE DOWNSTREAM SLOPE.

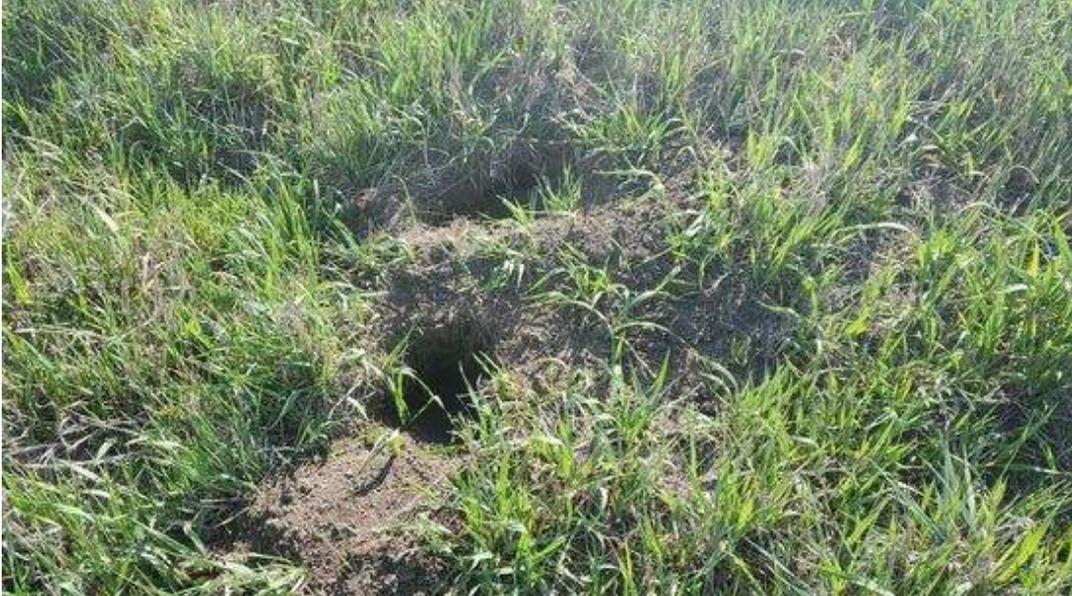
Photo Number: 13

Direction: SE Short Description or Location: Downstream Slope
Detailed Description: RODENT HOLES ON DOWNSTREAM SLOPE OF THE DAM.

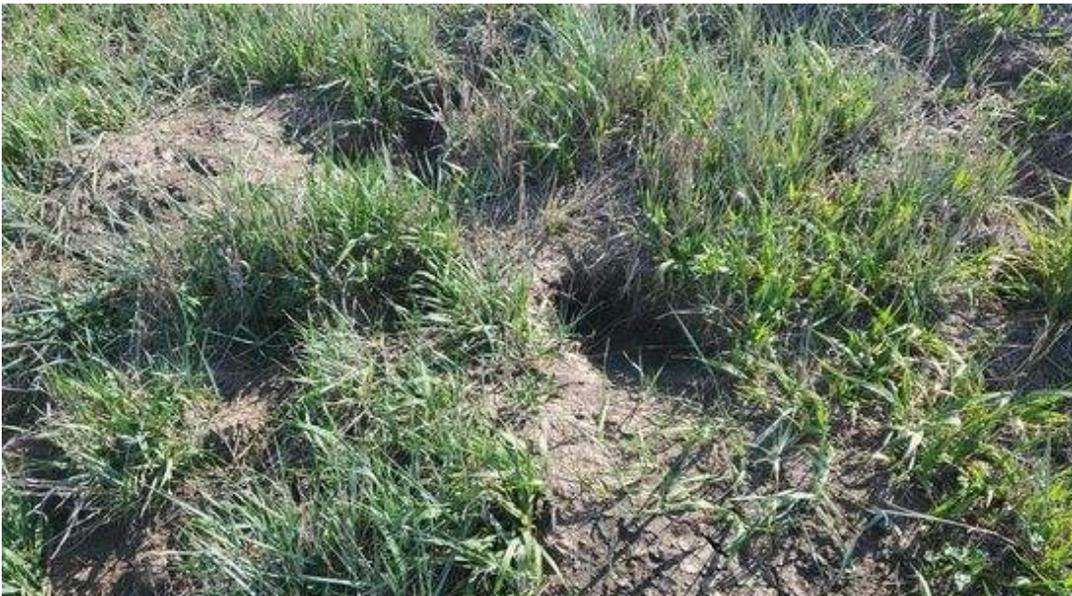
Photo Number: 14

Direction: SW Short Description or Location: Downstream Slope
Detailed Description: RODENT HOLES ON DOWNSTREAM SLOPE OF THE DAM.

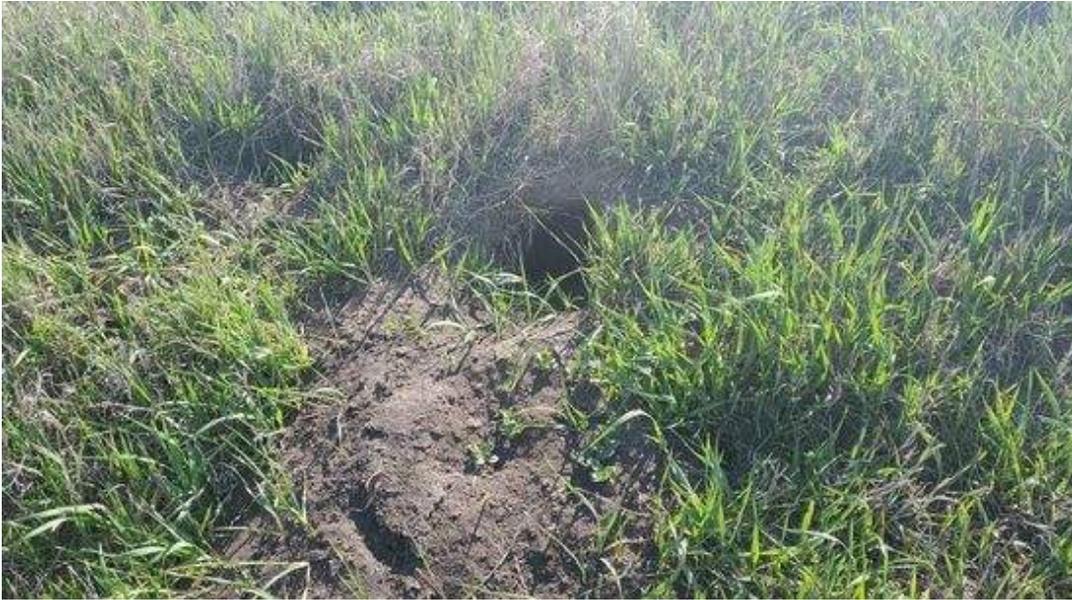
Photo Number: 15

Direction: SE Short Description or Location: Downstream Slope
Detailed Description: RODENT HOLES ON DOWNSTREAM SLOPE OF THE DAM.

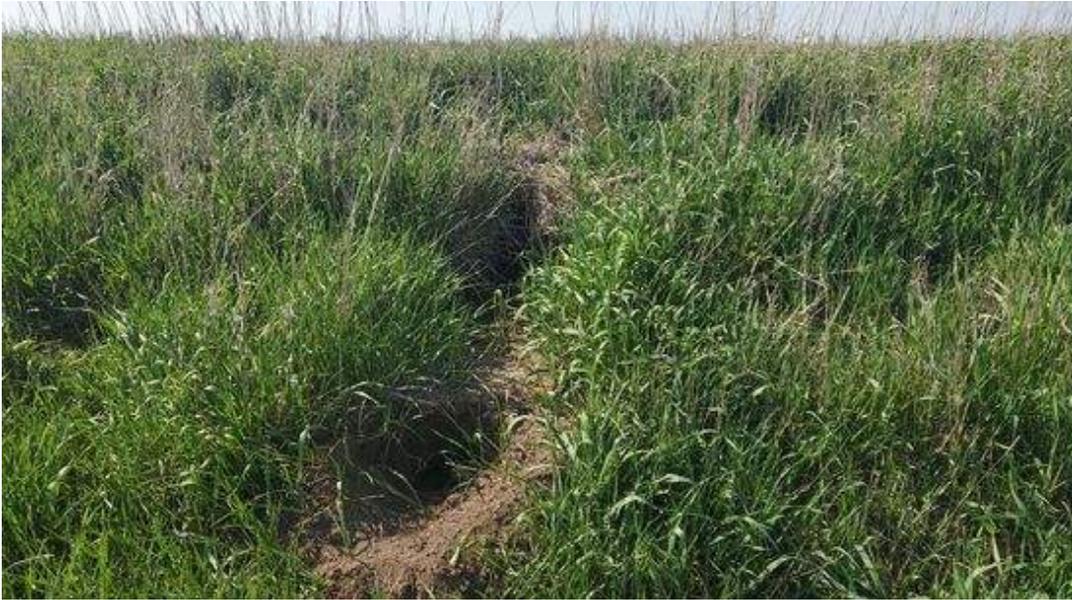
Photo Number: 19

Direction: S Short Description or Location: Downstream Slope
Detailed Description: RODENT HOLES ON THE DOWNSTREAM SLOPE BY INLET PIPE ON THE NORTH.

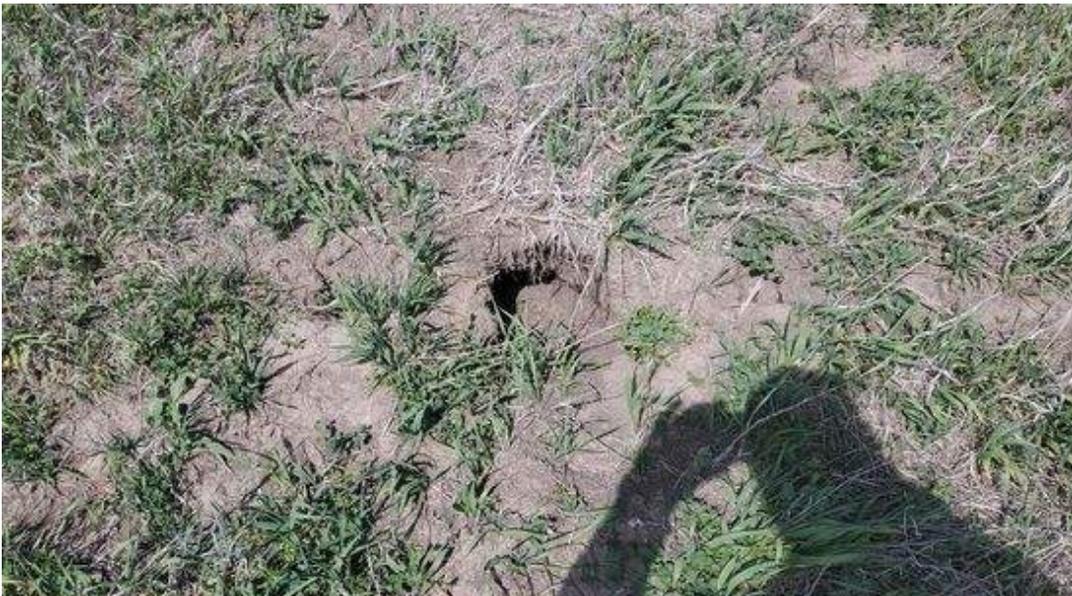
Photo Number: 28

Direction: NW Short Description or Location: Upstream Slope
Detailed Description: RODENT HOLE ON UPSTREAM SLOPE.

- d) *Top of Dam* – Fill in rodent holes and monitor rodent activity. Reseed at the southern bend.
- e) *Upstream Slope* – Fill in rodent holes and monitor rodent activity. Reseed and monitor longitudinal and dry cracking. If the cracks on the slope continue to grow, acquire the services of a Professional Engineer to recommend and design improvements.
- f) *Downstream Slope* – Fill in rodent holes and monitor rodent activity.
- g) *Principal Spillway Pipe/Outlet* – Monitor and remove woody vegetation next to outlet pipe.

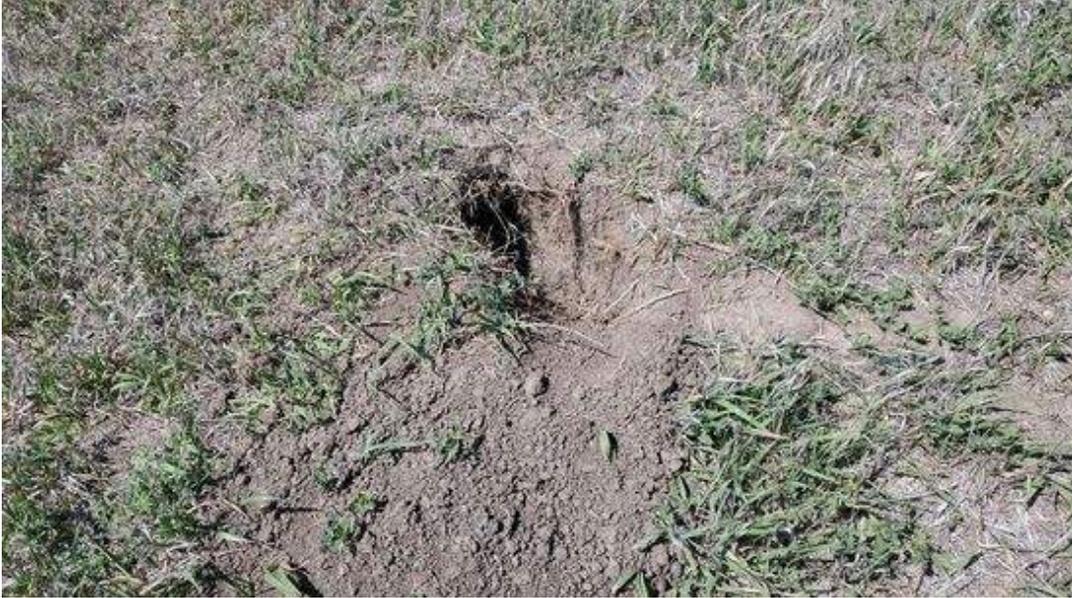
Photo Number: 29

Direction: NW Short Description or Location: Upstream Slope
Detailed Description: RODENT HOLE ON UPSTREAM SLOPE.

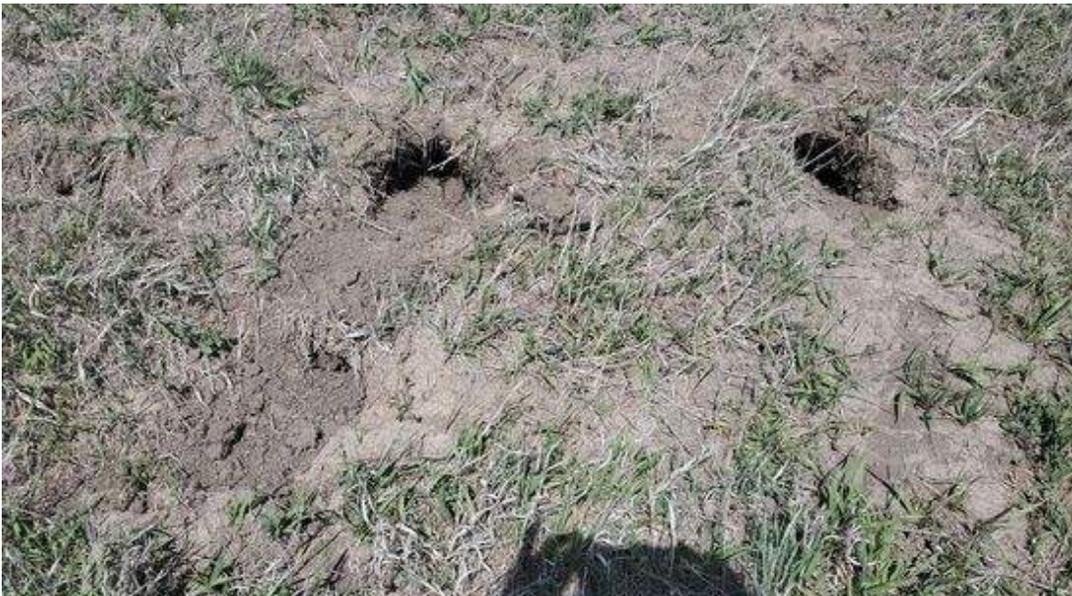
Photo Number: 30

Direction: SW Short Description or Location: Top of Dam
Detailed Description: RODENT HOLE ON TOP OF THE DAM.

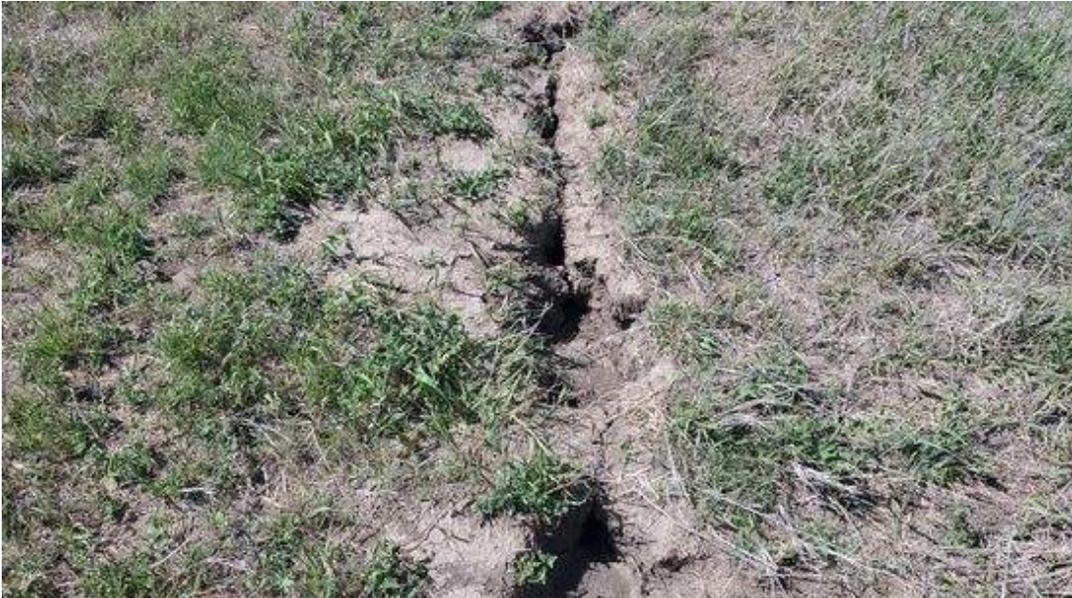
Photo Number: 31

| ITEM | RATING | REMARKS |
|---|---|--|
| E. Cracks, Settlement or Bulges? | 2 | MINOR LONGITUDINAL AND DRY CRACKING ON THE UPSTREAM SLOPE. |

Direction: SW Short Description or Location: Upstream Slope
Detailed Description: LONGITUDINAL CRACKING ON UPSTREAM SLOPE.

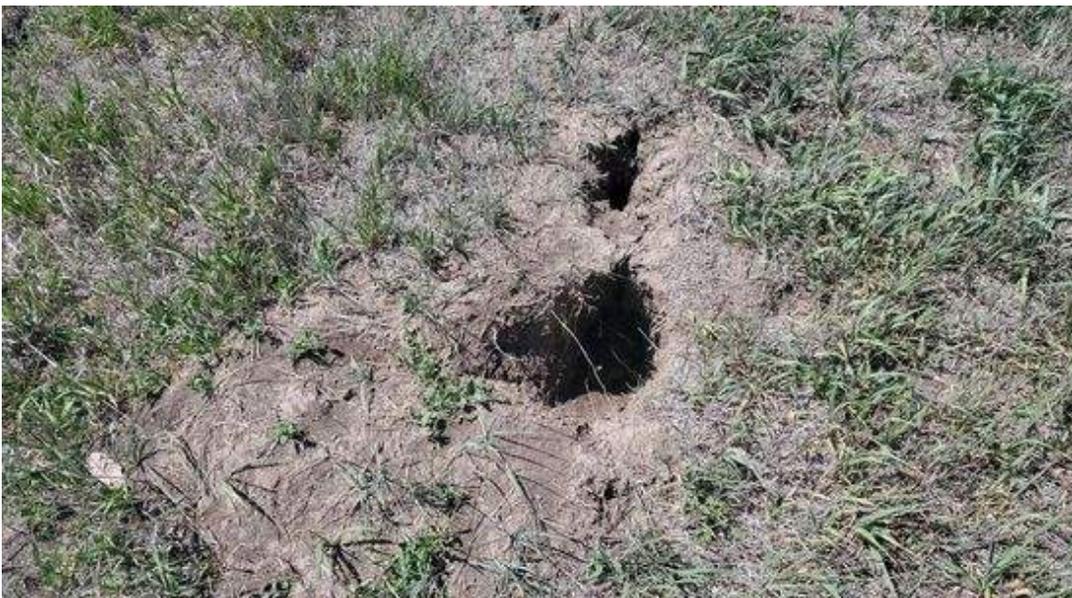
Photo Number: 32

Direction: SW Short Description or Location: Top of Dam
Detailed Description: RODENT HOLE ON UPSTREAM SLOPE.

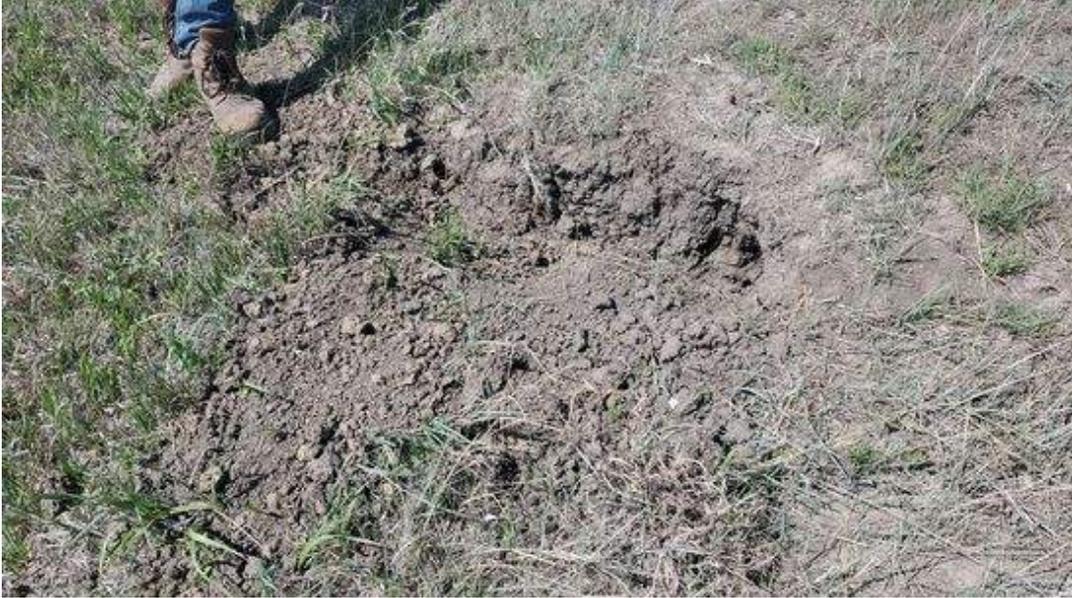
Photo Number: 33

Direction: SW Short Description or Location: Upstream Slope
Detailed Description: RODENT HOLE ON UPSTREAM SLOPE.

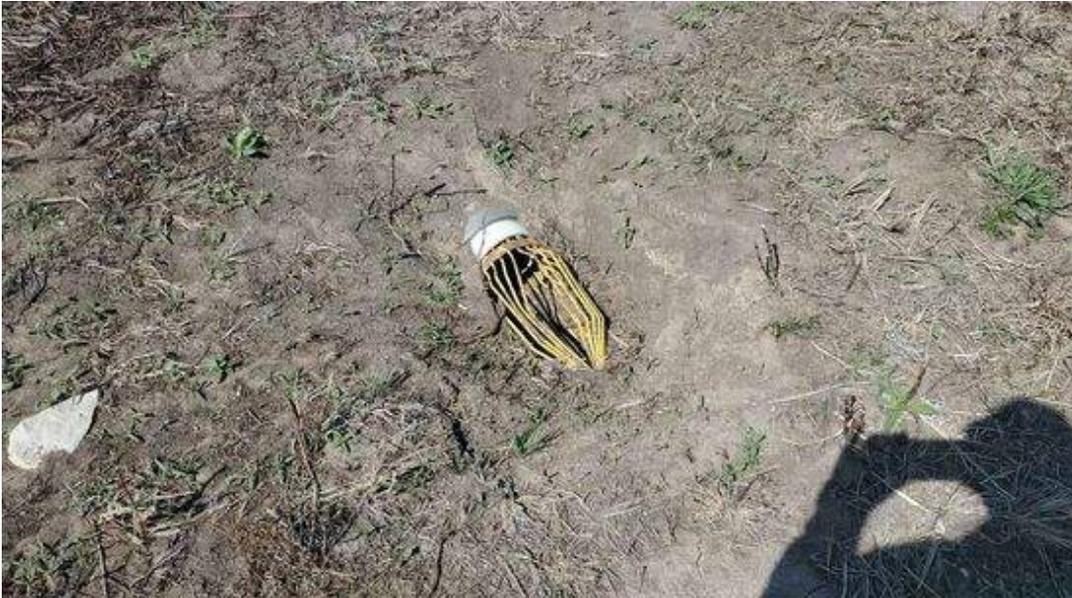
Photo Number: 43

| ITEM | RATING | REMARKS |
|---|---|--|
| B. Deterioration? | 2 | METAL GRATE ON THE PIPE LEADING TO THE DRAWDOWN INLET STRUCTURE IS DAMAGED. |

Direction: NW Short Description or Location: Principal Spillway Inlet
Detailed Description: PRINCIPAL SPILLWAY INLET LEADER PIPE WITH DAMAGED GRATE.
