Dam Safety Inspection Report Sedgwick, Kansas

KDA DWR WSN: DHV-0052
PEC PROJECT NO. 237088-002-1223
June 2023

PREPARED BY
Professional Engineering Consultants, P.A.
400 S. Kansas Ave. Ste. 200
Topeka, KS 66603
785-233-8300

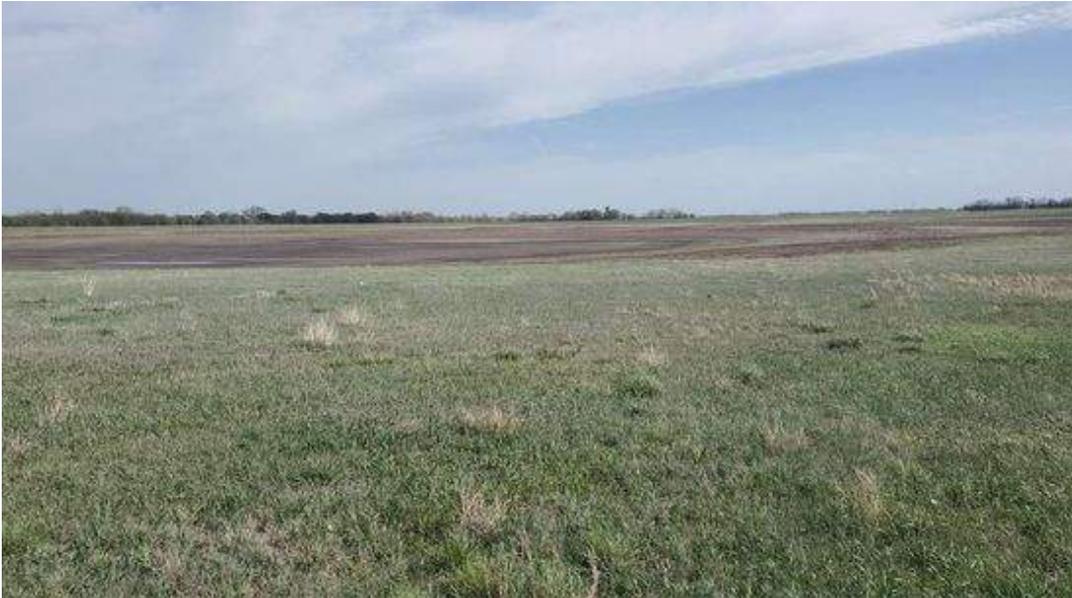
Photo Number: 1

Direction: N Short Description or Location: Emergency Spillway
Detailed Description: THE POND FROM THE EMERGENCY SPILLWAY.

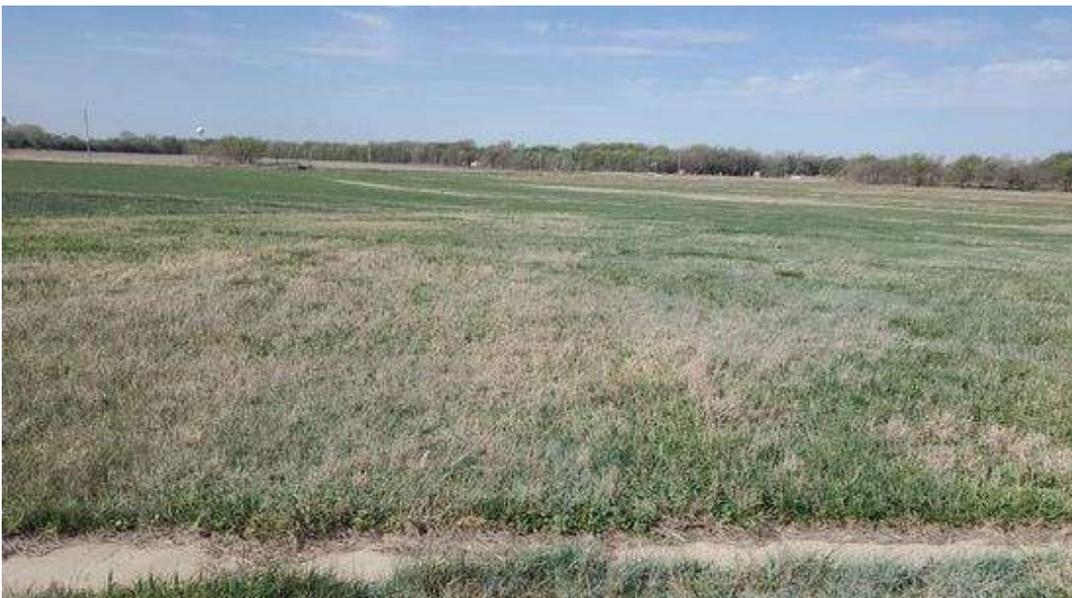
Photo Number: 2

Direction: SW Short Description or Location: Emergency Spillway
Detailed Description: THE EMERGENCY SPILLWAY FROM THE UPSTREAM SIDE.

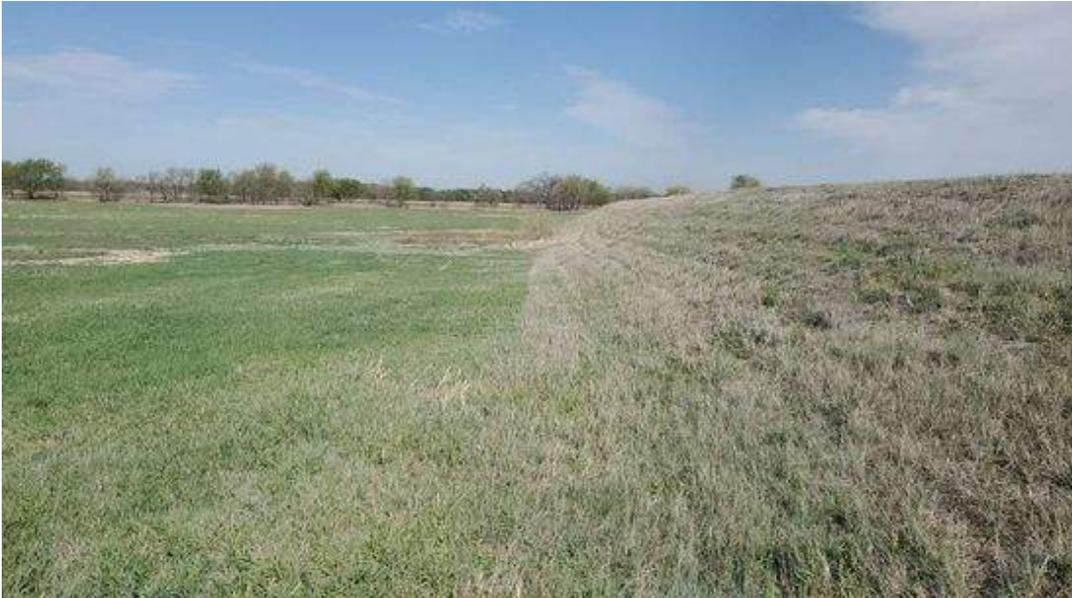
Photo Number: 3

Direction: NW Short Description or Location: Emergency Spillway
Detailed Description: THE DOWNSTREAM SLOPE OF DAM FROM THE EMERGENCY SPILLWAY.

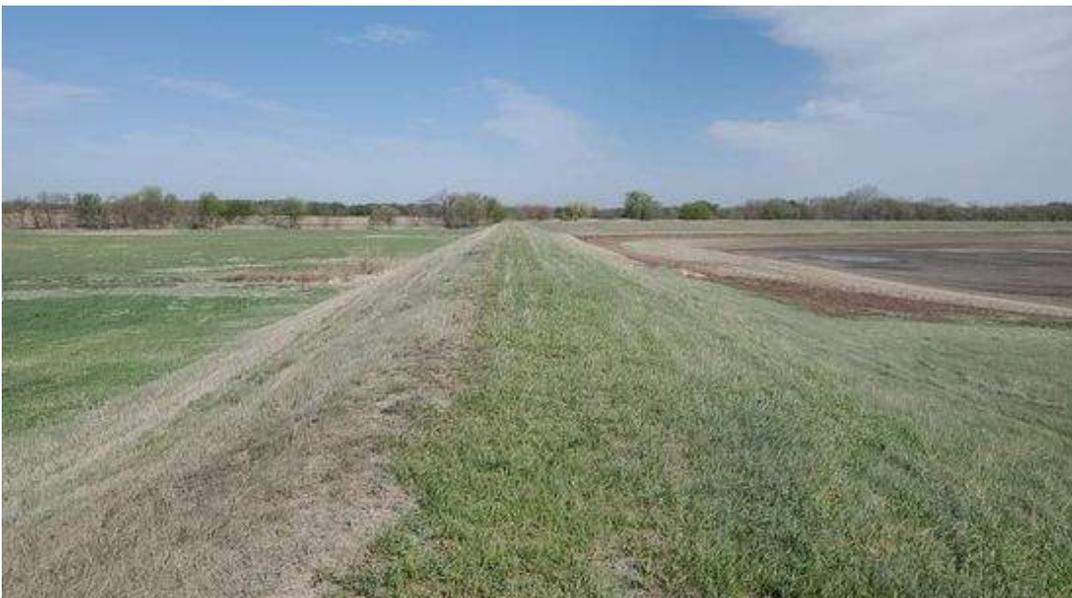
Photo Number: 4

Direction: NW Short Description or Location: Top of Dam
Detailed Description: THE TOP OF THE DAM FROM THE SOUTHERN START OF THE DAM.

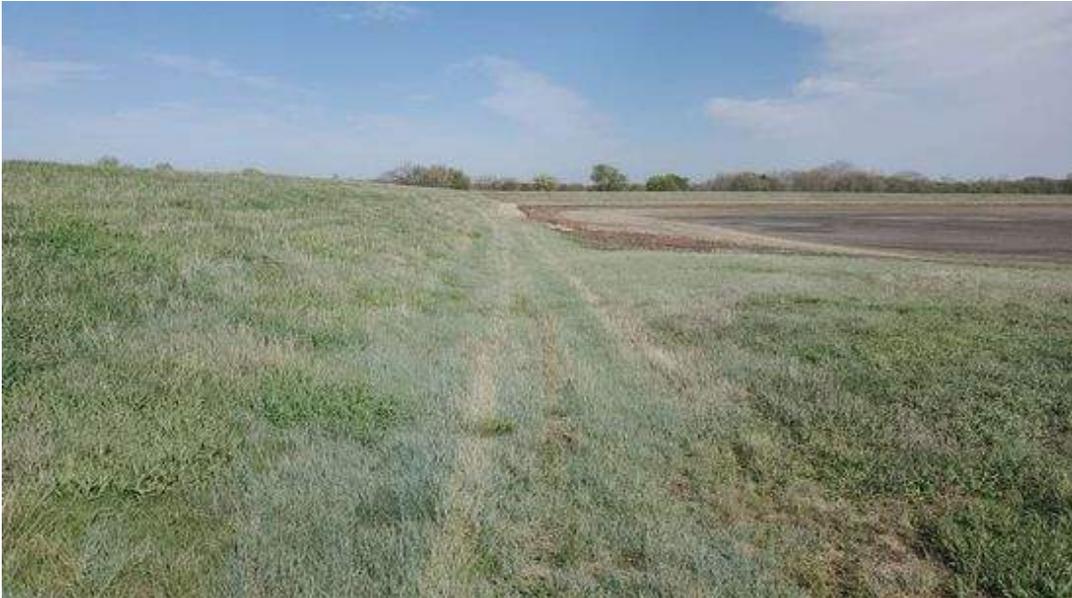
Photo Number: 5

Direction: NW Short Description or Location: Upstream Slope
Detailed Description: THE UPSTREAM SLOPE OF THE DAM FROM THE SOUTHERN START OF THE DAM.

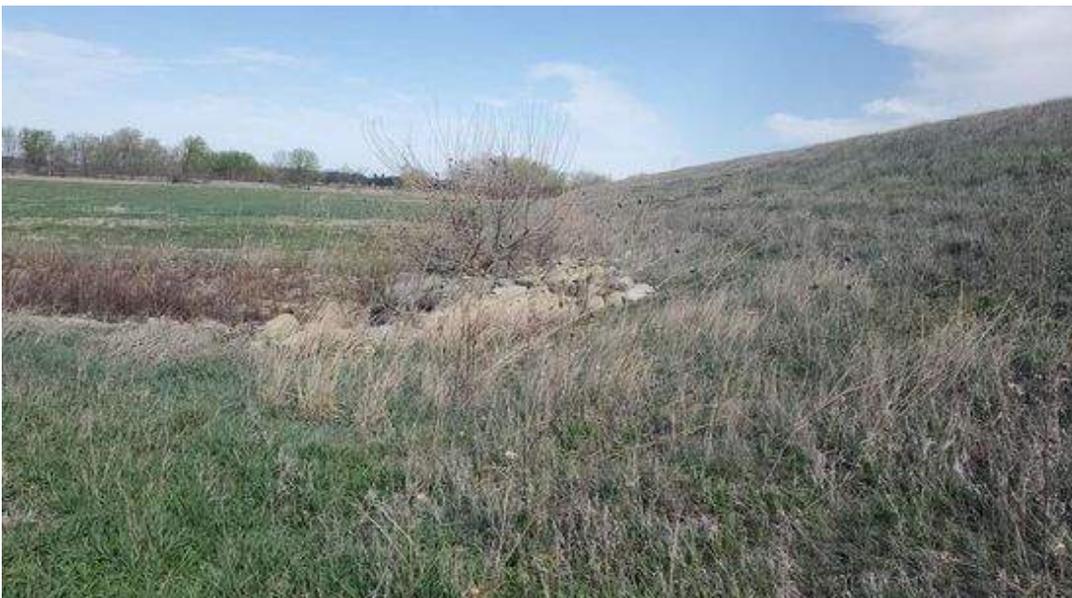
Photo Number: 6

Direction: NW Short Description or Location: Principal Spillway Outlet
Detailed Description: THE PRINCIPAL SPILLWAY OUTLET AND THE DOWNSTREAM SLOPE OF THE DAM.

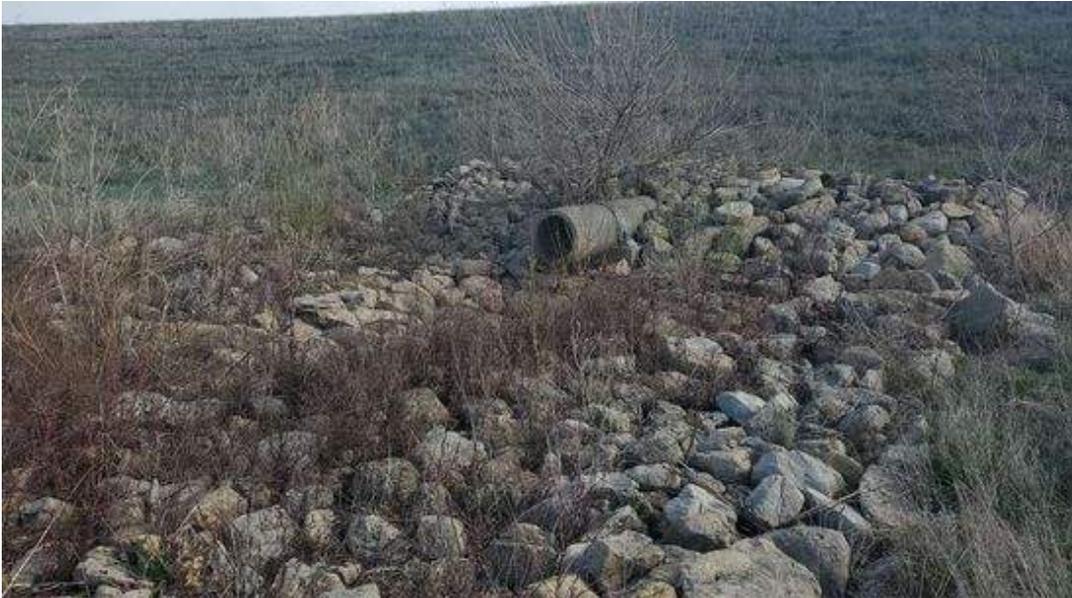
Photo Number: 7

- a) *Top of Dam* – One active and several inactive rodent holes found.
- b) *Upstream Slope* – Multiple inactive rodent holes found along the slope. Minor longitudinal and dry cracking present.
- c) *Principal Spillway Pipe/Inlet* – Metal grate on the pipe leading to the drawdown inlet structure is damaged.
- d) *Downstream Slope* – sporadic inactive rodent holes on the slope. Minor longitudinal and dry cracking present.
- e) *Principal Spillway Pipe/Outlet* – Woody vegetation next to outlet pipe.

Direction: N Short Description or Location: Principal Spillway Outlet
Detailed Description: THE PRINCIPAL SPILLWAY OUTLET PIPE.

- d) *Top of Dam* – Fill in rodent holes and monitor rodent activity. Reseed at the southern bend.
- e) *Upstream Slope* – Fill in rodent holes and monitor rodent activity. Reseed and monitor longitudinal and dry cracking. If the cracks on the slope continue to grow, acquire the services of a Professional Engineer to recommend and design improvements.
- f) *Downstream Slope* – Fill in rodent holes and monitor rodent activity.
- g) *Principal Spillway Pipe/Outlet* – Monitor and remove woody vegetation next to outlet pipe.

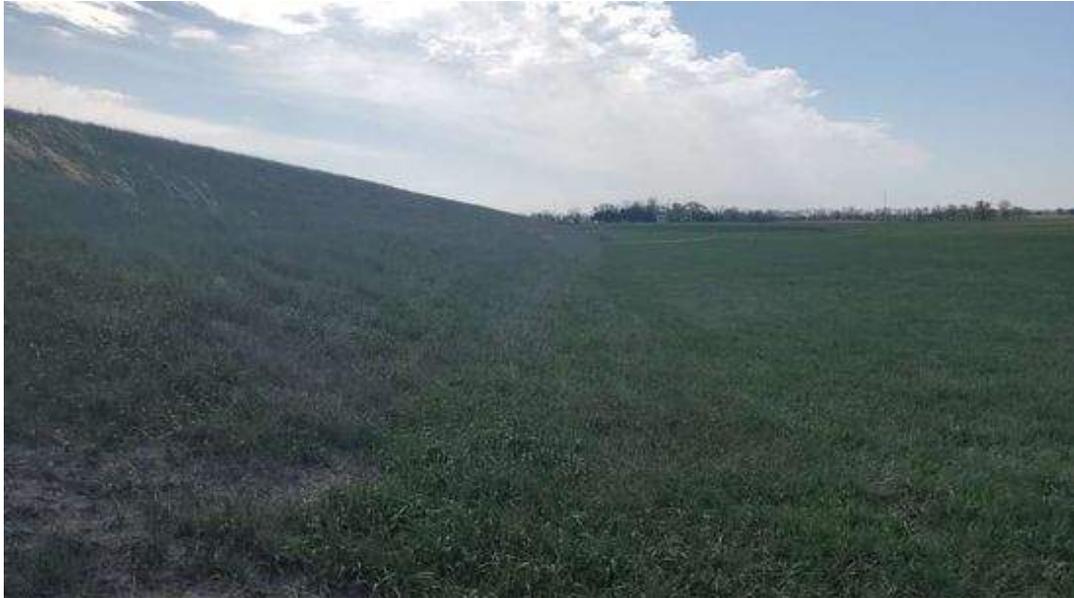
Photo Number: 9

Direction: SE Short Description or Location: Downstream Slope
Detailed Description: DOWNSTREAM SLOPE OF THE DAM FROM THE SOUTH BEND LOOKING SOUTHEAST.

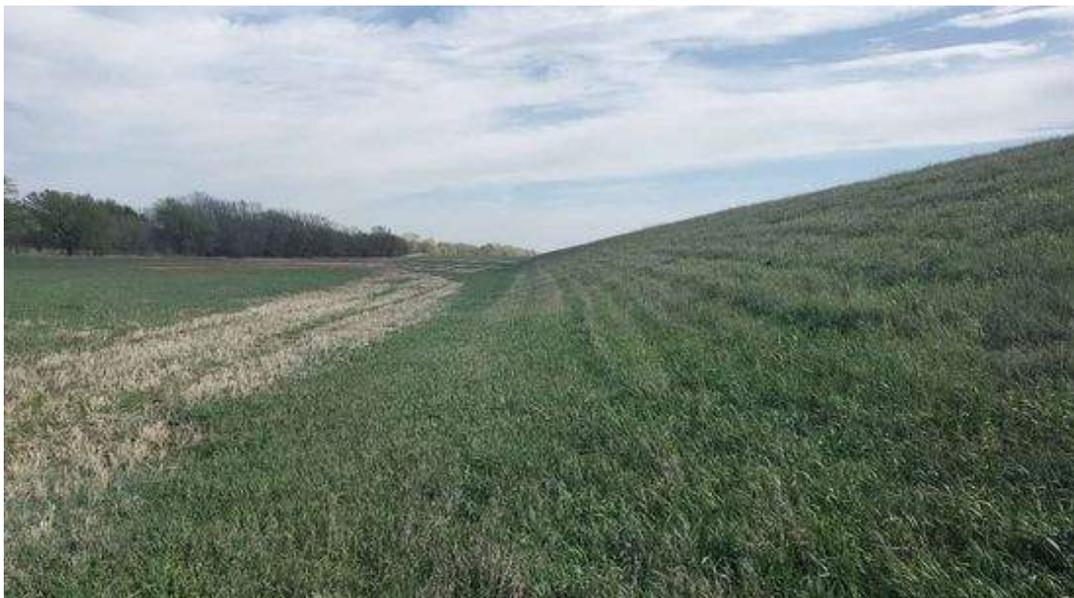
Photo Number: 10

Direction: NE Short Description or Location: Downstream Slope
Detailed Description: DOWNSTREAM SLOPE OF THE DAM FROM THE SOUTH BEND LOOKING NORTHEAST.

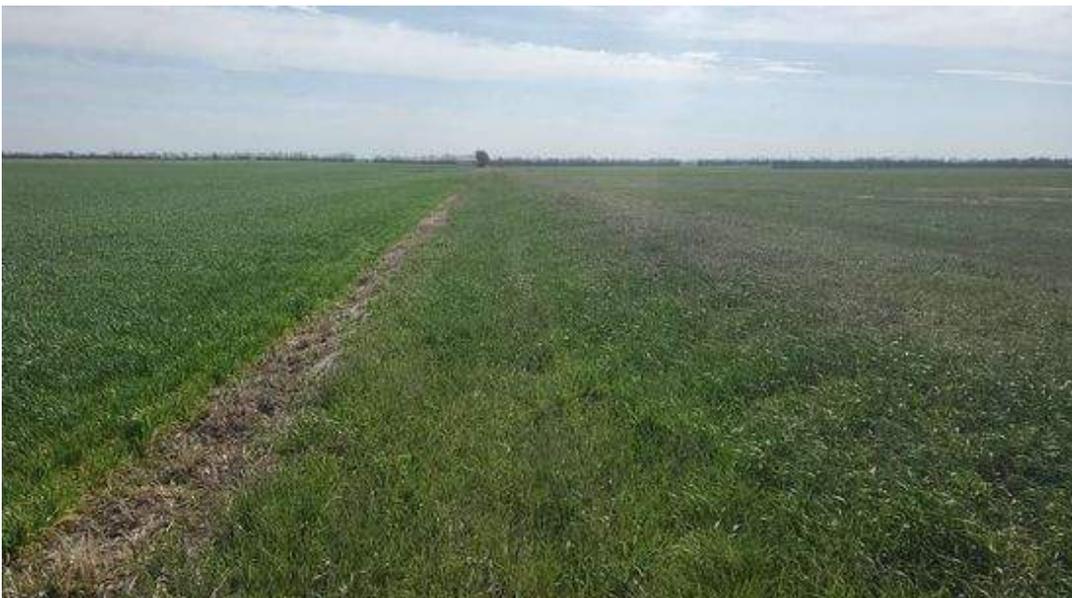
Photo Number: 16

Direction: E Short Description or Location: Downstream Slope
Detailed Description: DOWNSTREAM SLOPE AT NORTH BEND LOOKING EAST.

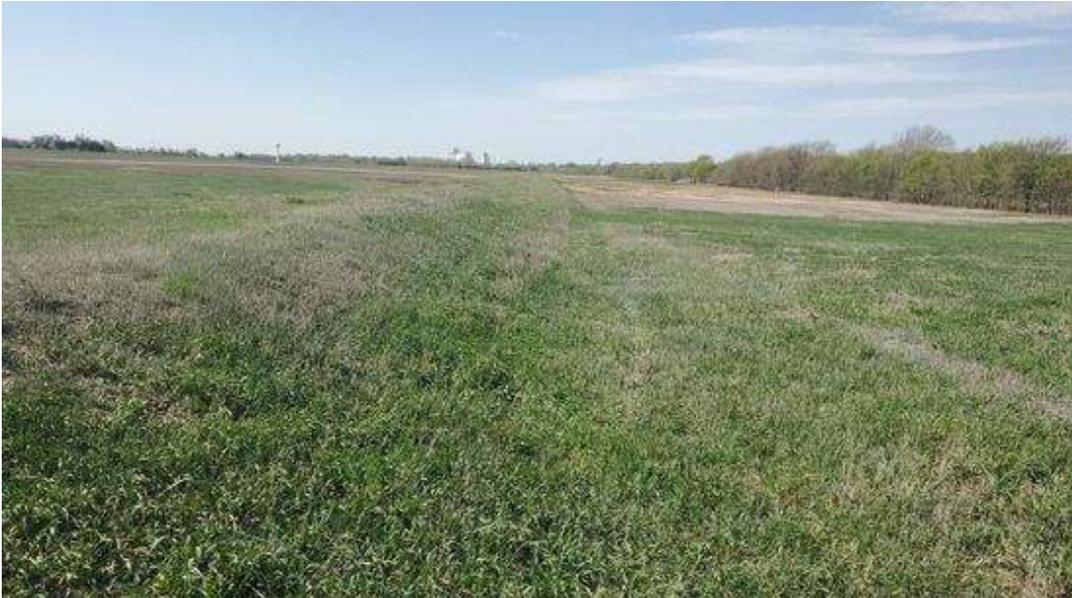
Photo Number: 17

Direction: SW Short Description or Location: Downstream Slope
Detailed Description: DOWNSTREAM SLOPE AT NORTH BEND LOOKING SOUTHWEST.

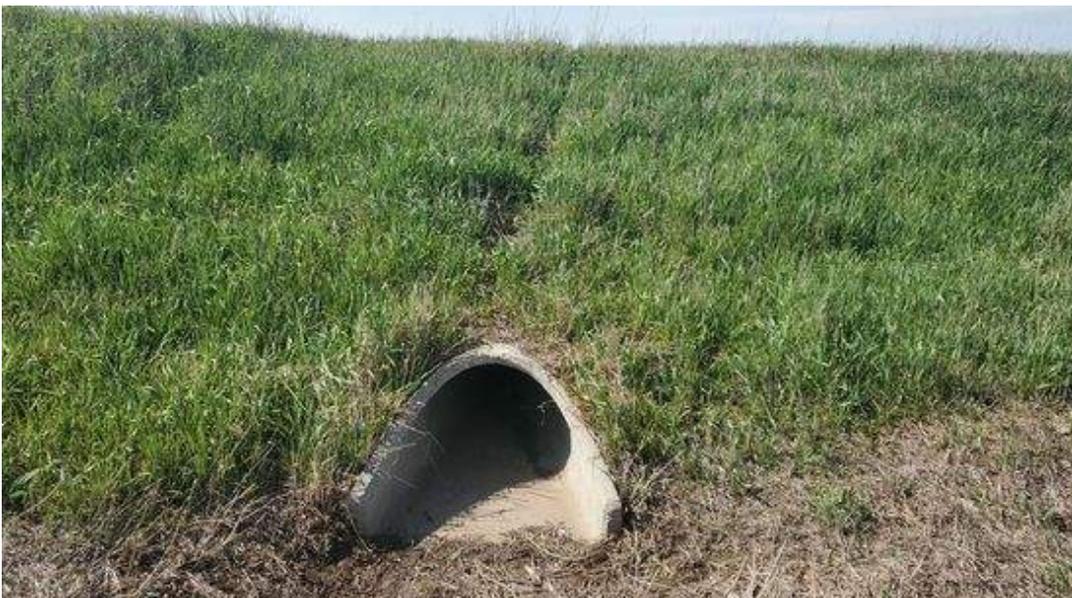
Photo Number: 18

Direction: S Short Description or Location: Downstream Slope
Detailed Description: INLET PIPE FROM ADJOINING FIELD.

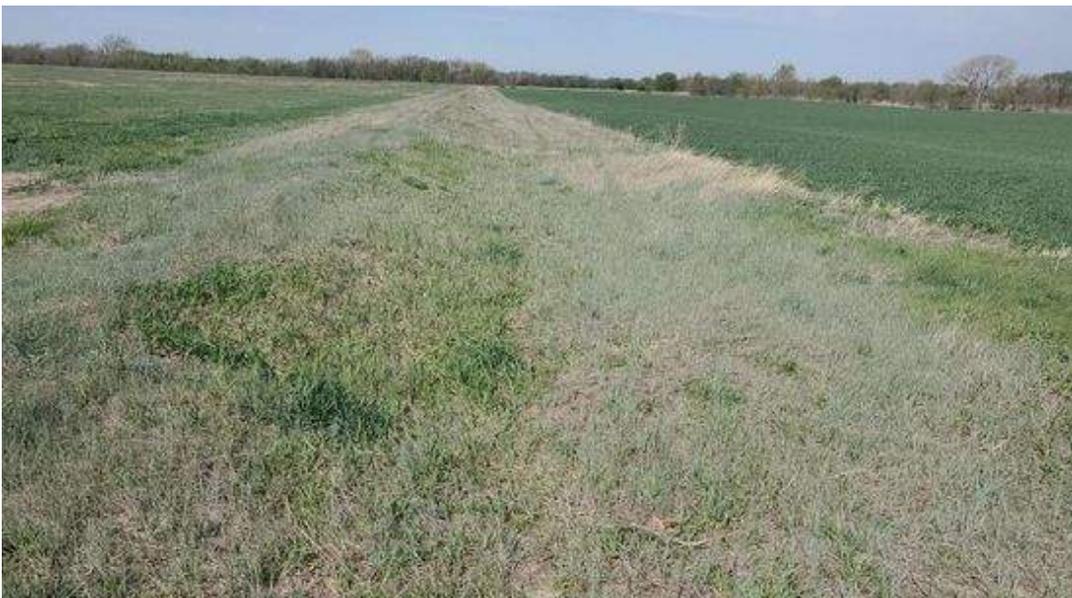
Photo Number: 20

Direction: W Short Description or Location: Downstream Slope
Detailed Description: THE DOWNSTREAM SLOPE OF THE DAM FROM THE NORTHERN START OF THE DAM.

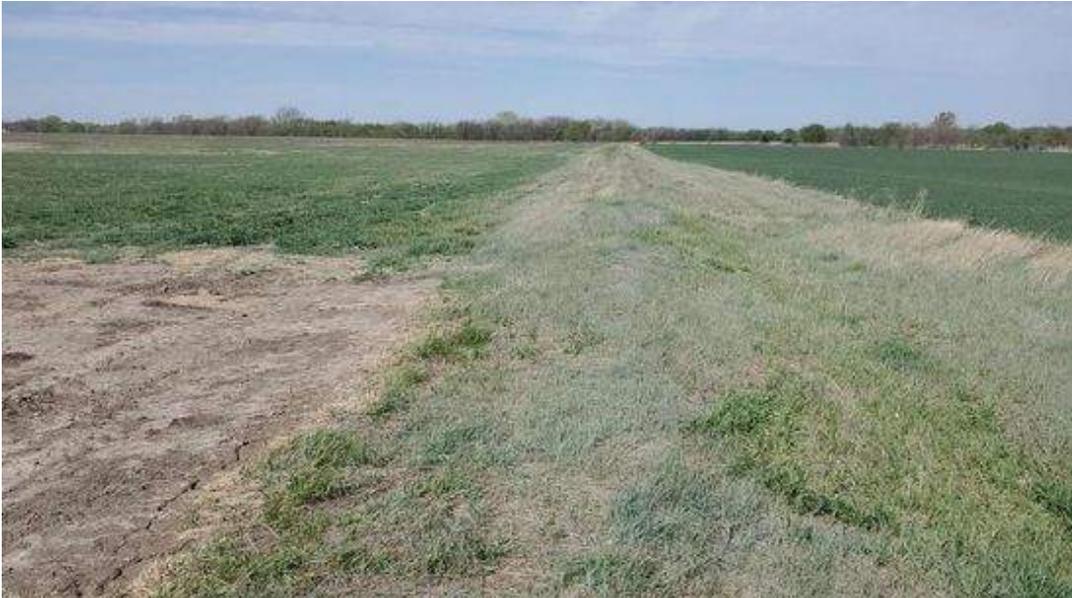
Photo Number: 21

Direction: W Short Description or Location: Top of Dam
Detailed Description: THE TOP OF THE DAM FROM THE NORTHERN START OF THE DAM.

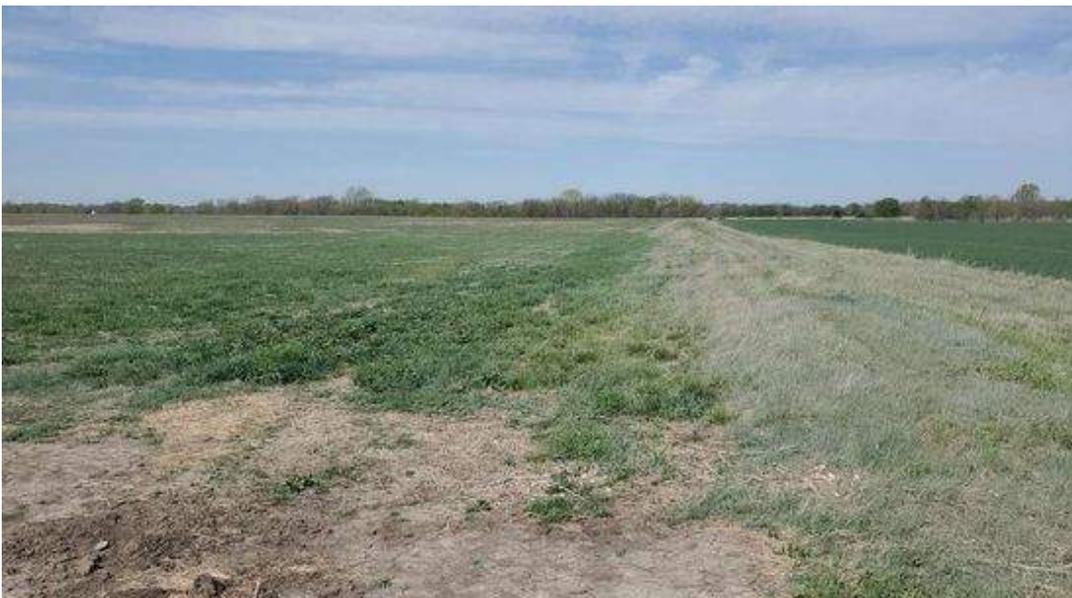
Photo Number: 22

Direction: W Short Description or Location: Upstream Slope
Detailed Description: THE UPSTREAM SLOPE OF THE DAM FROM THE NORTHERN START OF THE DAM.

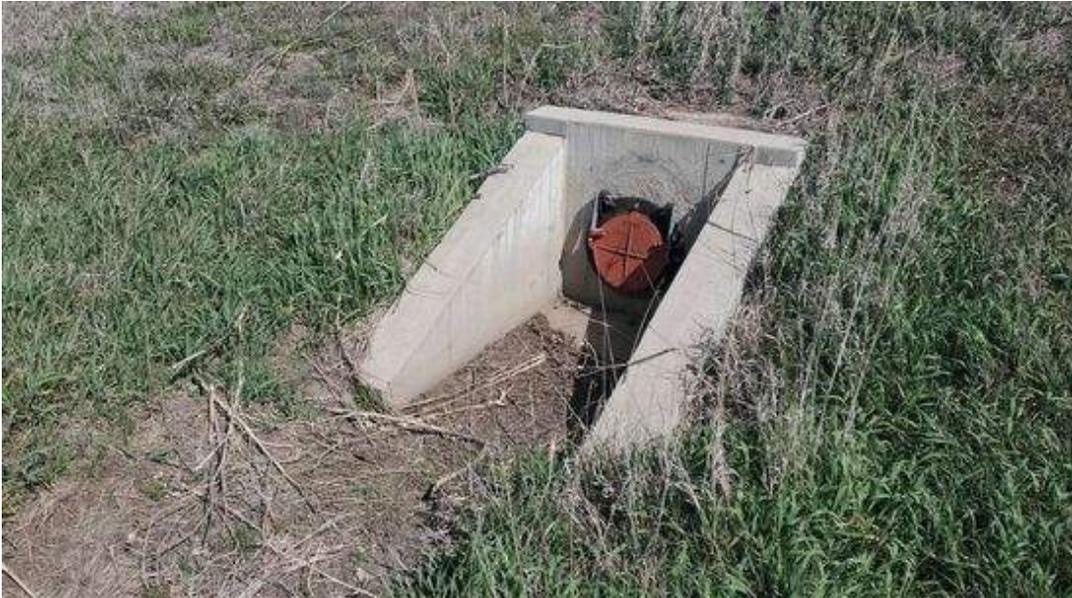
Photo Number: 23

Direction: NW Short Description or Location: Upstream Slope
Detailed Description: OUTLET WITH FLAP GATE OF THE PIPE FROM ADJOINING FIELD.

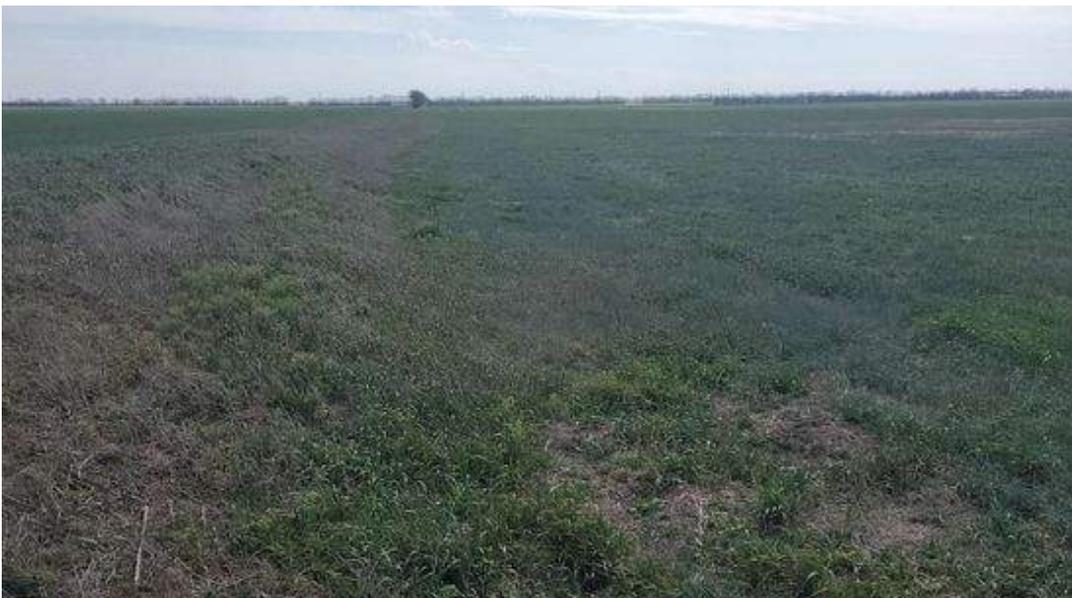
Photo Number: 24

Direction: E Short Description or Location: Upstream Slope
Detailed Description: UPSTREAM SLOPE AT NORTHERN BEND LOOKING EAST.

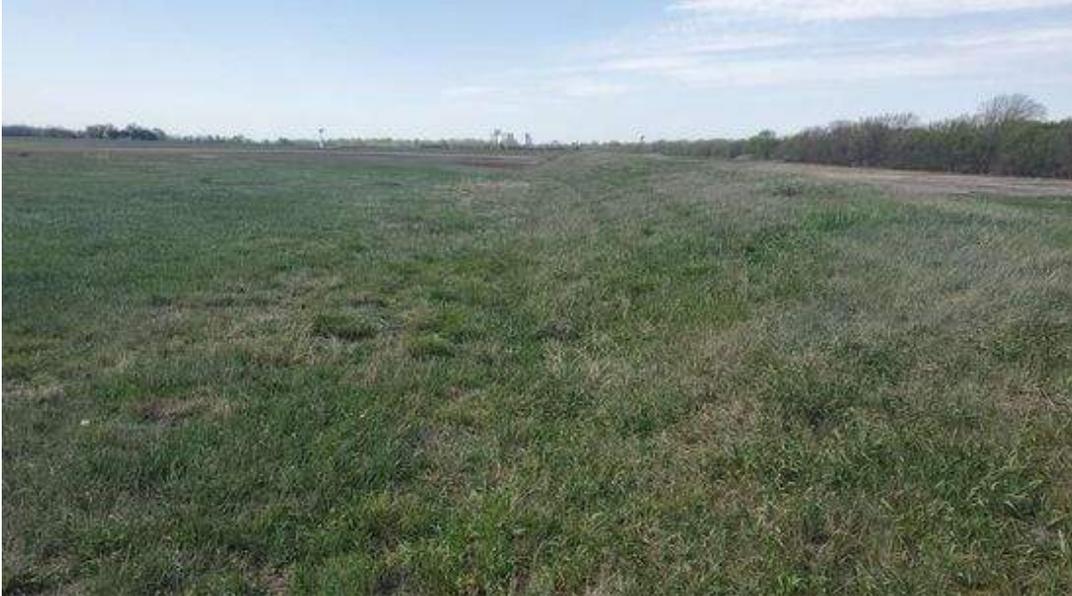
Photo Number: 25

Direction: SW Short Description or Location: Upstream Slope
Detailed Description: UPSTREAM SLOPE AT NORTH BEND LOOKING SOUTHWEST.

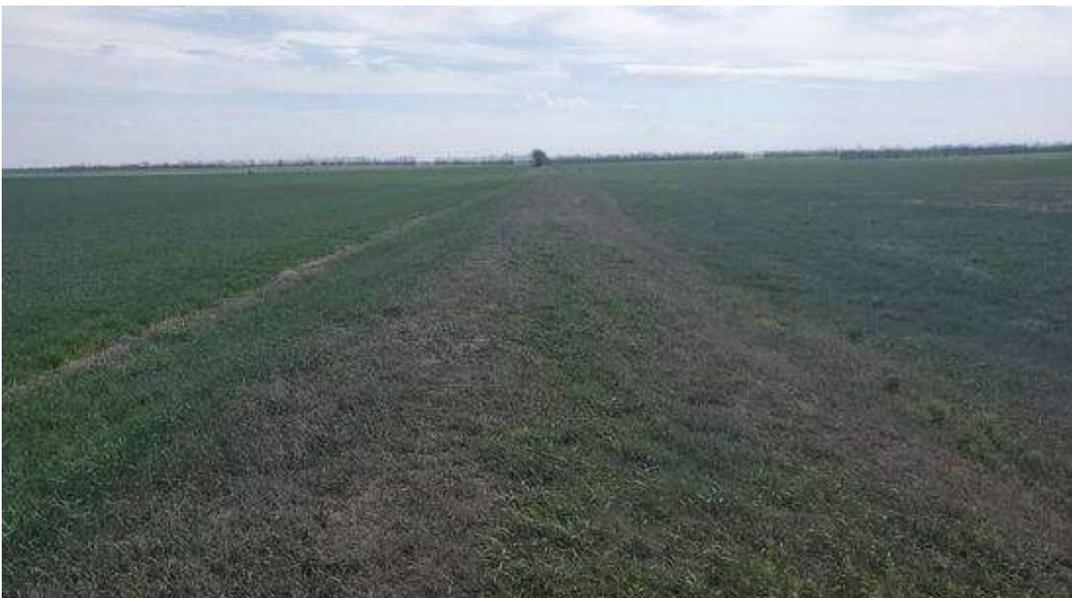
Photo Number: 26

Direction: E Short Description or Location: Top of Dam
Detailed Description: TOP OF DAM AT NORTH BEND LOOKING EAST.

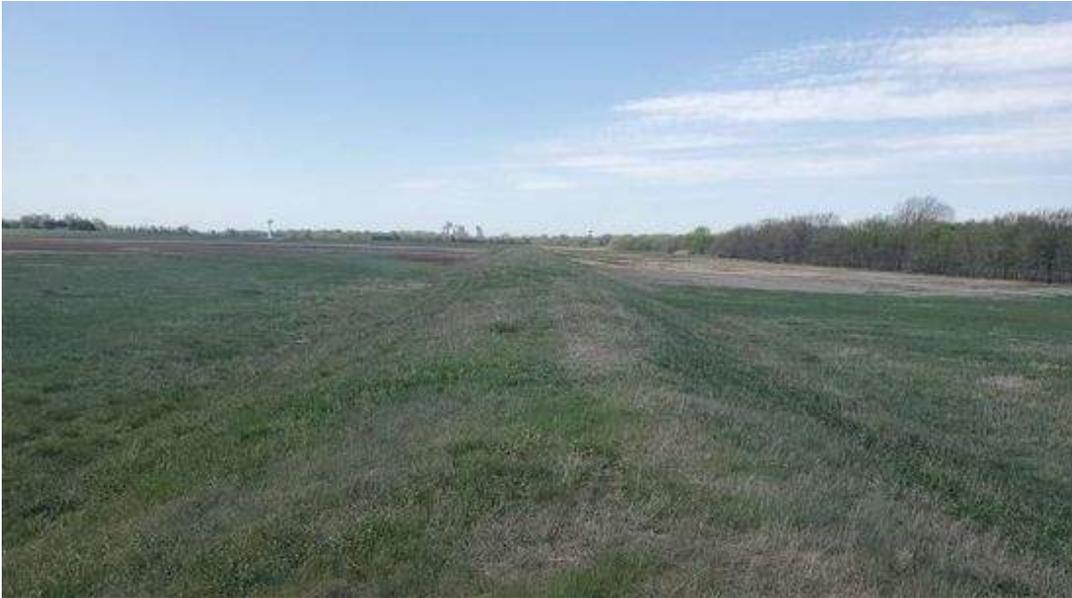
Photo Number: 27

Direction: SW Short Description or Location: Top of Dam
Detailed Description: TOP OF DAM AT NORTH BEND LOOKING SOUTHWEST.

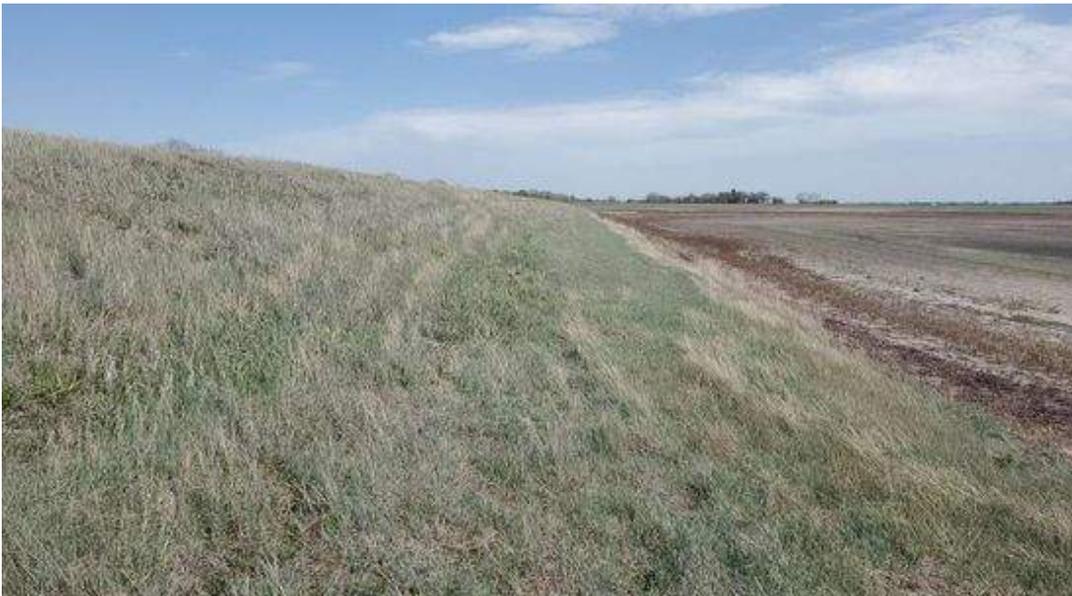
Photo Number: 34

Direction: NE Short Description or Location: Upstream Slope
Detailed Description: UPSTREAM SLOPE AT SOUTH BEND LOOKING NORTHEAST.

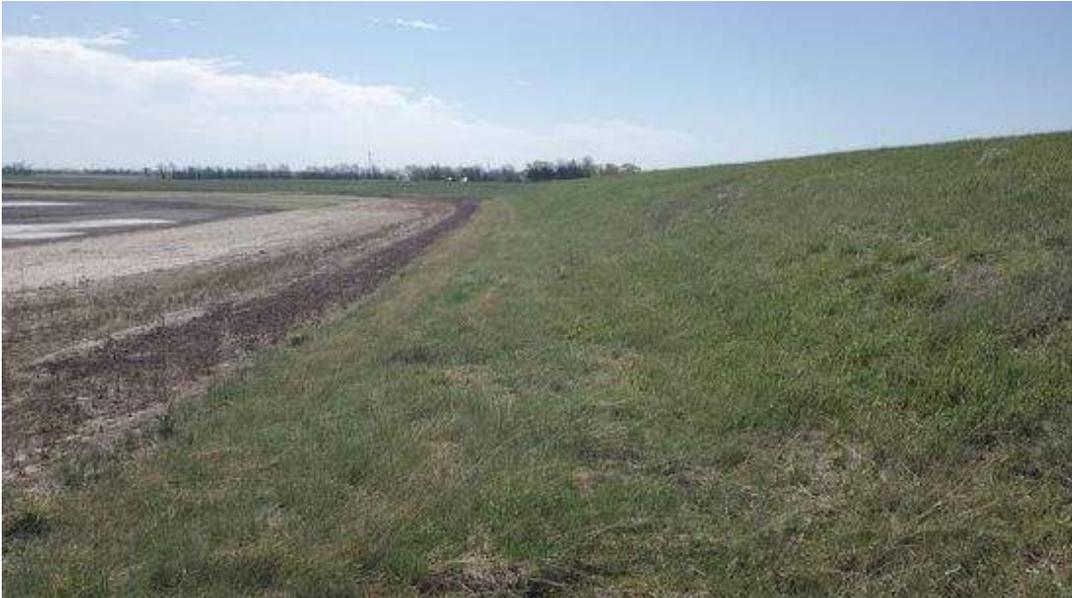
Photo Number: 35

Direction: SE Short Description or Location: Wave Berm
Detailed Description: WAVE BERM & UPSTREAM SLOPE AT SOUTH BEND LOOKING SOUTHEAST.

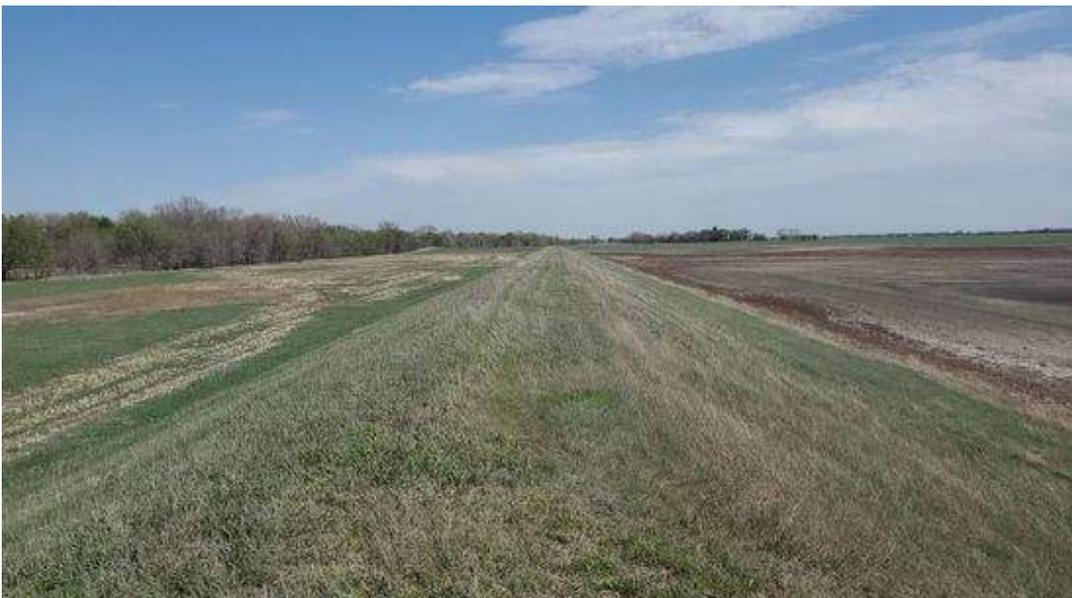
Photo Number: 36

Direction: NE Short Description or Location: Top of Dam
Detailed Description: TOP OF DAM AT SOUTH BEND LOOKING NORTHEAST.

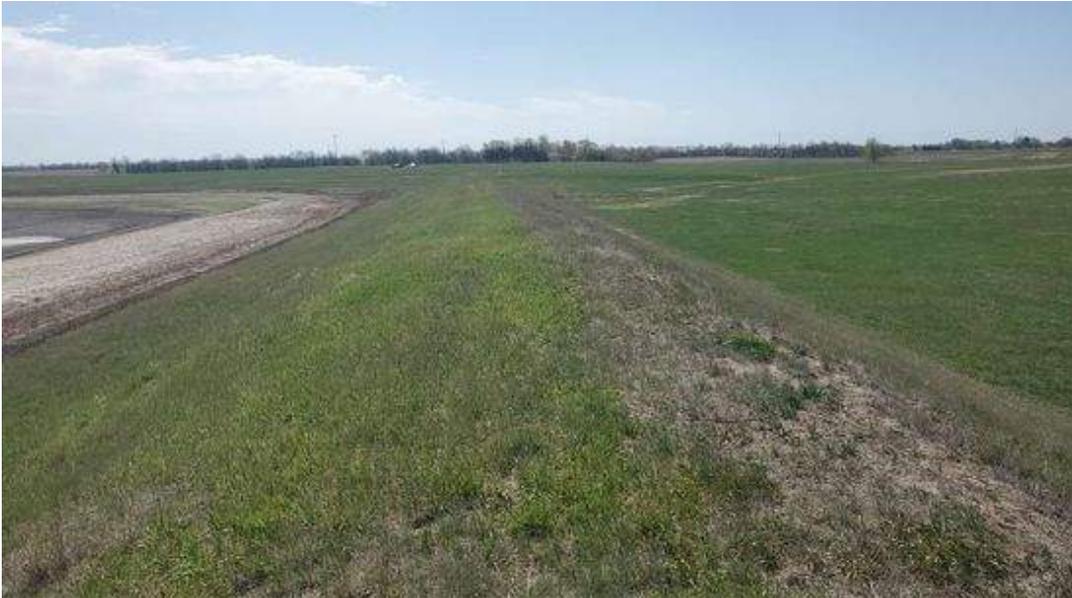
Photo Number: 37

Direction: SE Short Description or Location: Top of Dam
Detailed Description: TOP OF DAM AT SOUTH BEND LOOKING SOUTHEAST.

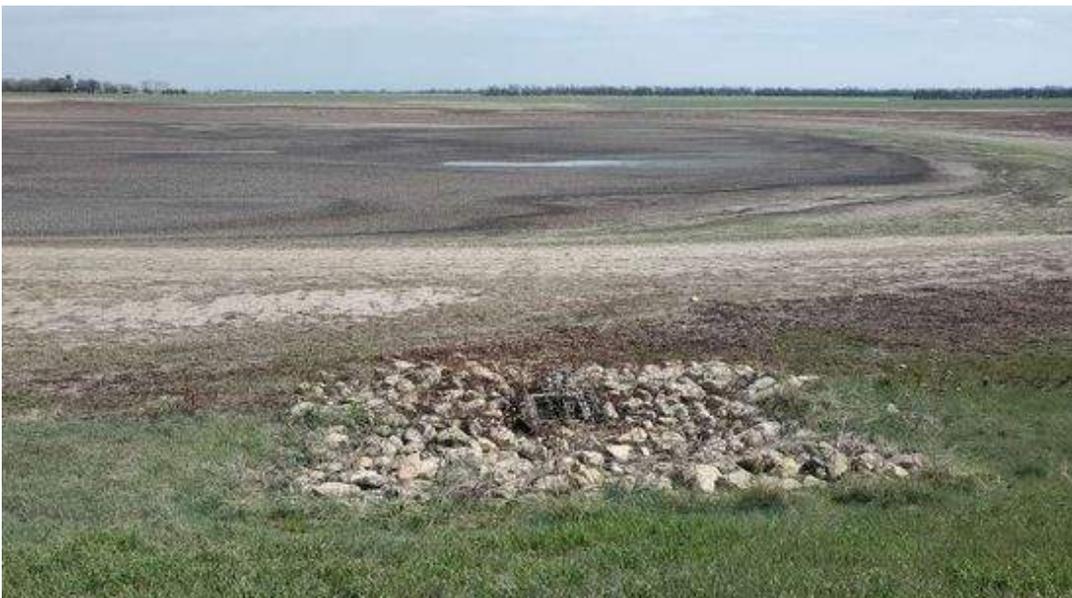
Photo Number: 38

Direction: NE Short Description or Location: Principal Spillway Inlet
Detailed Description: PRINCIPAL SPILLWAY INLET FROM TOP OF DAM.

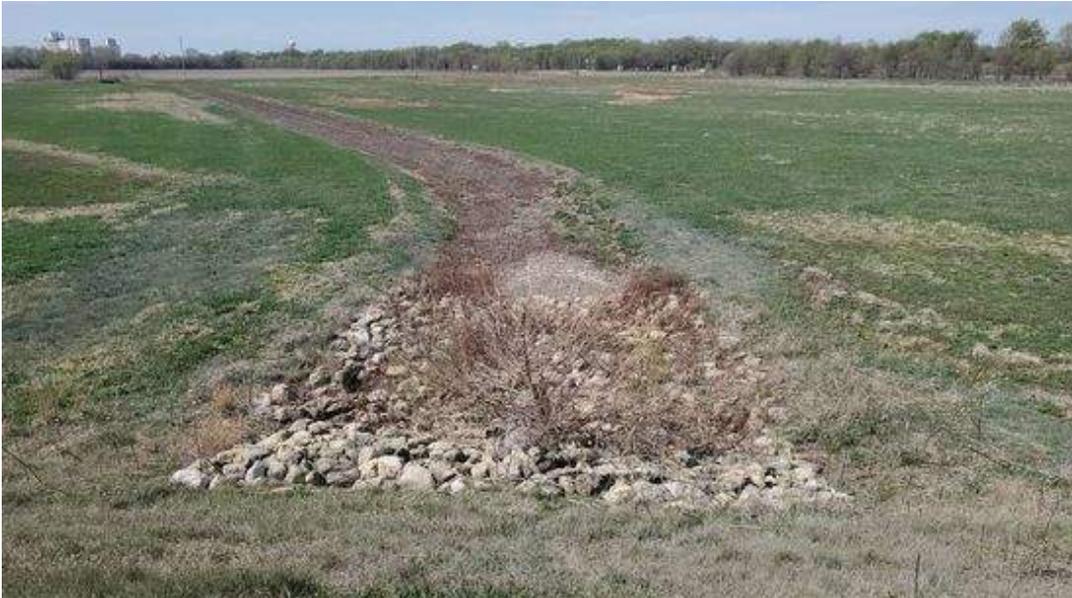
Photo Number: 39

Direction: SW Short Description or Location: Principal Spillway Outlet
Detailed Description: PRINCIPAL SPILLWAY OUTLET FROM TOP OF DAM.

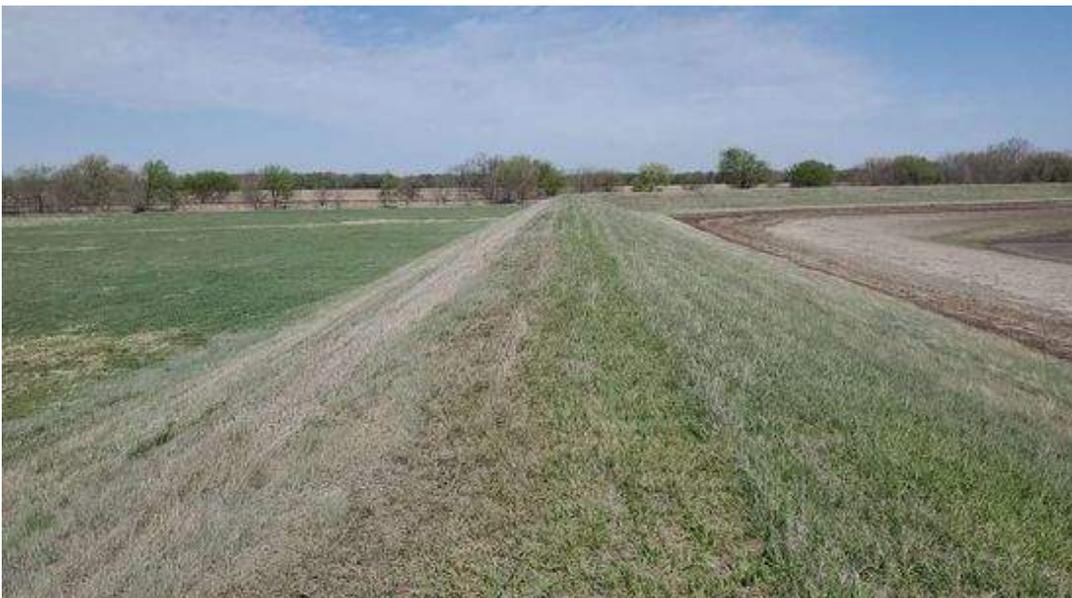
Photo Number: 40

Direction: NW Short Description or Location: Top of Dam
Detailed Description: TOP OF DAM AT PRINCIPAL SPILLWAY LOOKING NORTHWEST.

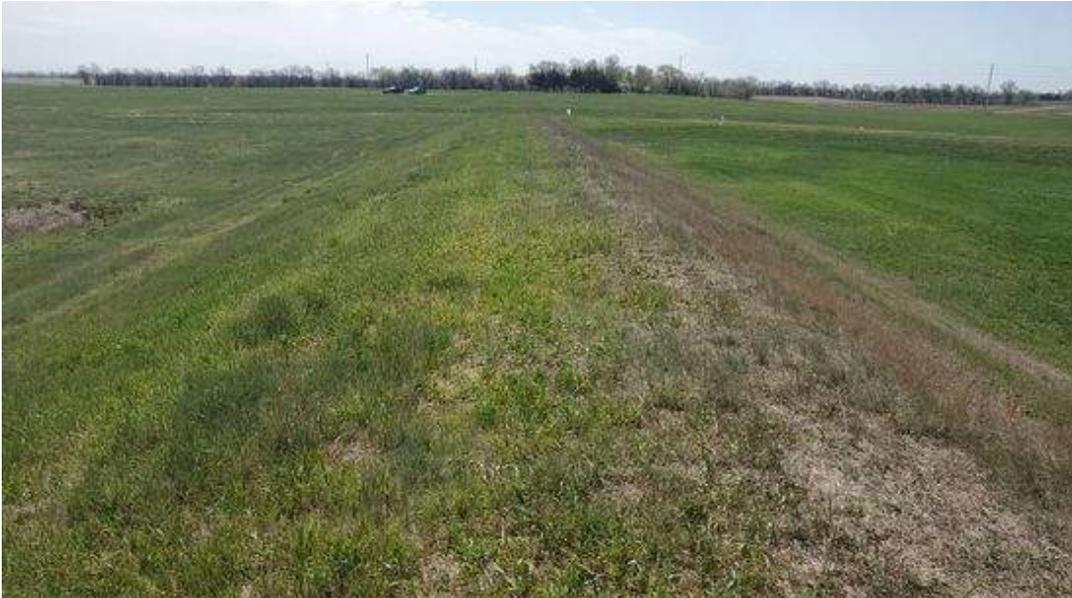
Photo Number: 41

Direction: SE Short Description or Location: Top of Dam
Detailed Description: TOP OF DAM AT PRINCIPAL SPILLWAY LOOKING SOUTHEAST.

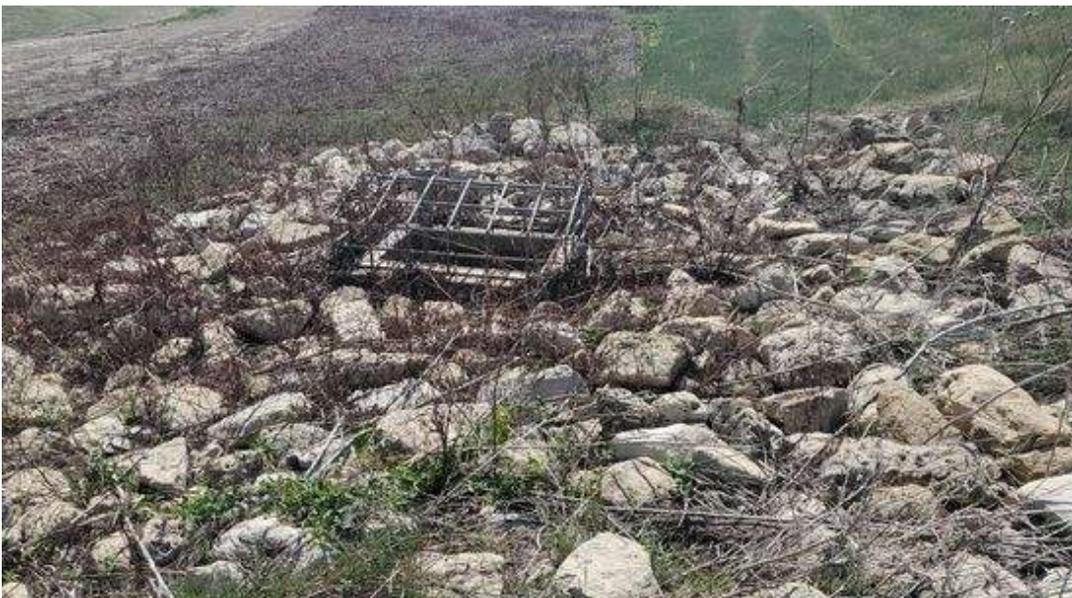
Photo Number: 42

Direction: SE Short Description or Location: Principal Spillway Inlet
Detailed Description: PRINCIPAL SPILLWAY INLET FROM UPSTREAM SLOPE OF DAM.

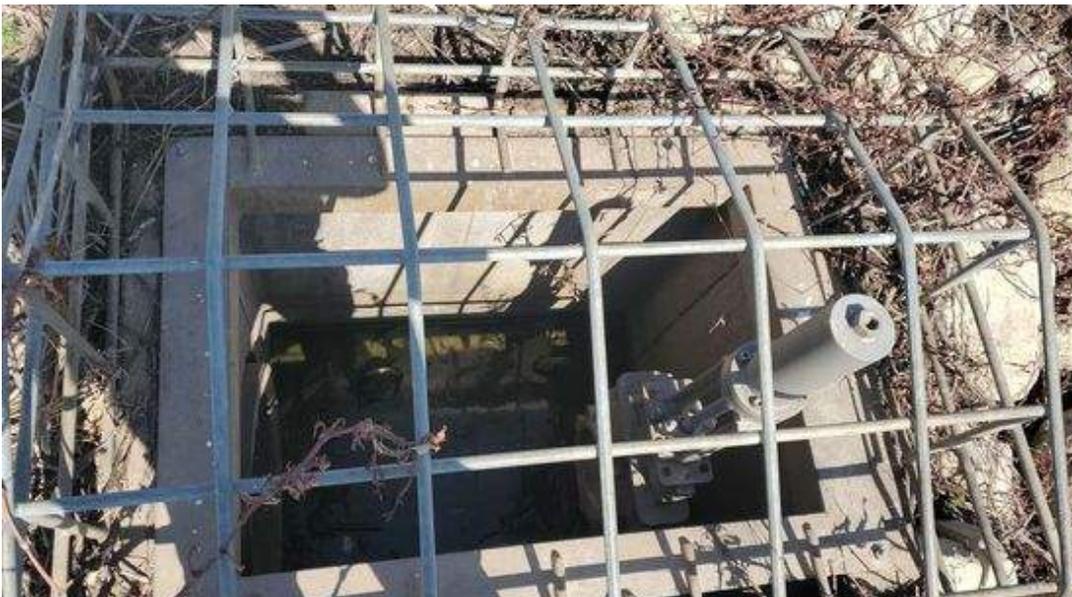
Photo Number: 44

Direction: NE Short Description or Location: Principal Spillway Inlet
Detailed Description: PRINCIPAL SPILLWAY INLET.
